# SERVICE BULLETIN

Classification: EL17-024	Reference: NTB17-067	Date: August 16, 2017
-----------------------------	-------------------------	--------------------------

## 2016-2017 MURANO; PHONE WILL NOT CONNECT WITH VEHICLE AND BLUETOOTH® AND PHONE BUTTONS ARE GRAYED OUT IN SETTINGS MENU

**APPLIED VEHICLES:** 2016-2017 Murano (Z52)  
2016 Murano Hybrid (Z52)

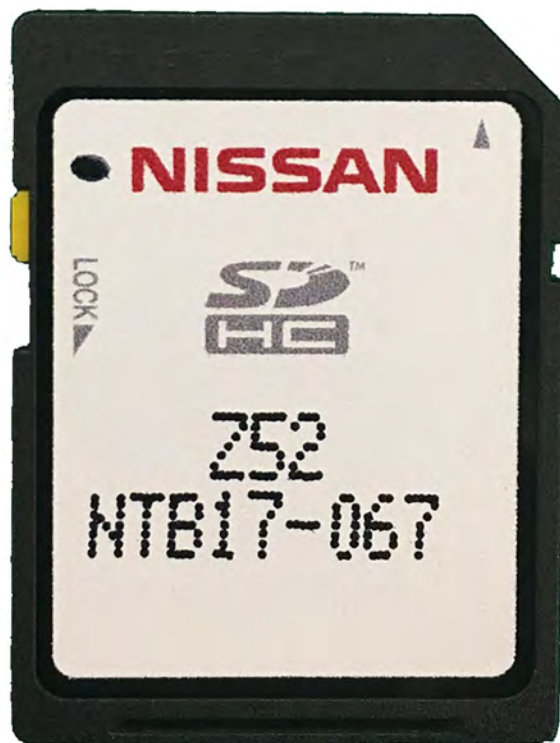
Figure B

## SD Card Information

- Each dealer has been mailed one software update SD card, free of charge, from Clarion.
- Replacement software update SD cards, due to loss or damage, can be obtained by contacting Clarion: 1-800-347-8933.

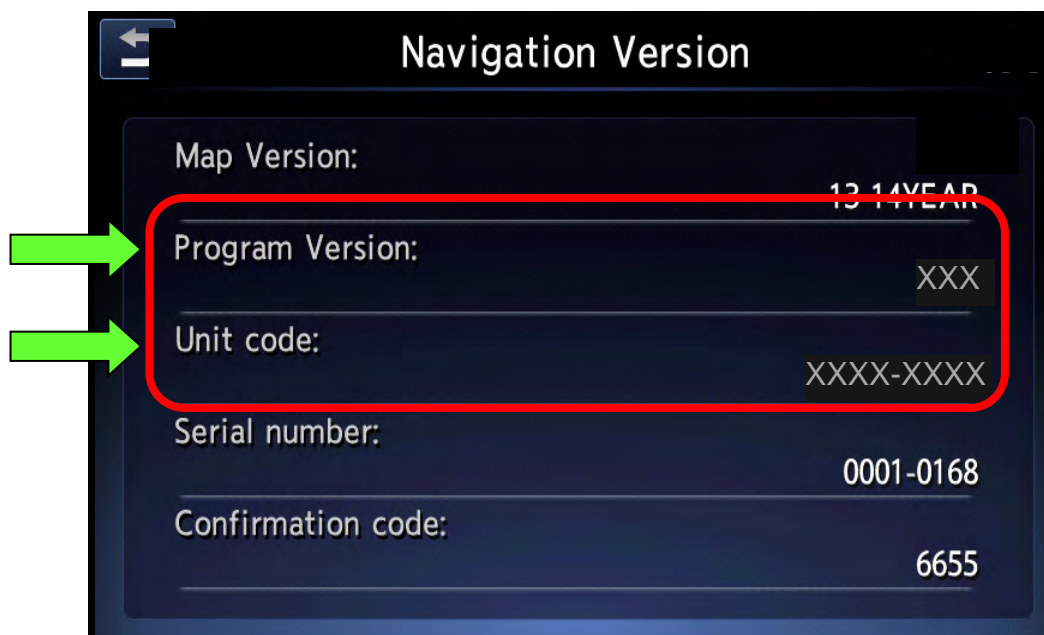
Figure 4

- For vehicles with Unit code QY84-\*\*NA or QY84-\*\*NB or QY84-\*\*NC:  
A software update is needed if the Program Version is not 565.

7. Write down the **Unit code** and **Program Version** values on the repair order, and then go to page 5, **AV Control Unit Software Update with Software Update SD Card**.

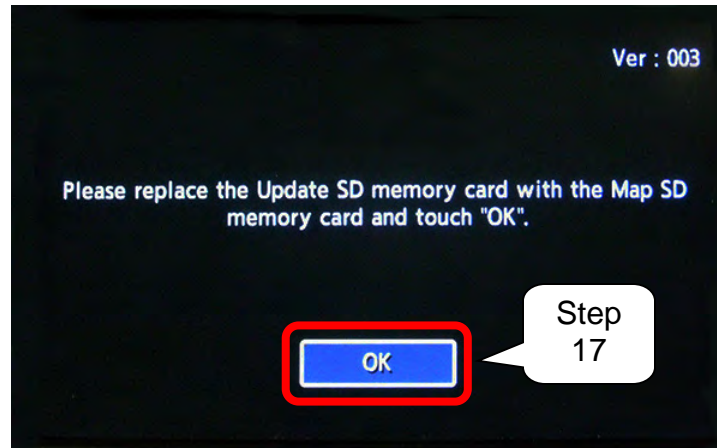
Figure 11

**Please replace the Update SD memory card with the MAP SD memory card and touch "OK".**

**NOTE:** If the message in Figure 10 (page 8) displays instead of the message in Figure 11, above, perform step 11-13 again.

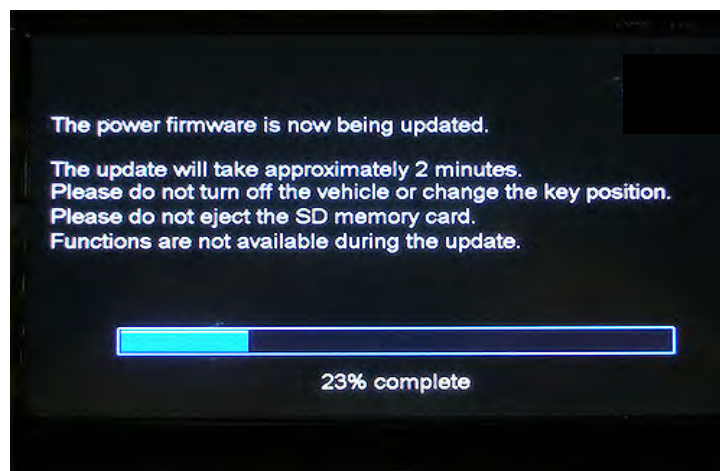
Figure 14

- The software update will take 10-20 minutes.

**CAUTION:** Make sure the hazard warning lamps continue to stay ON. If the vehicle powers down automatically during AV control unit software updating, the AV control unit may be rendered inoperable.
