**Technical Service Webinar**  
January, 2017

# Technical Service Webinar

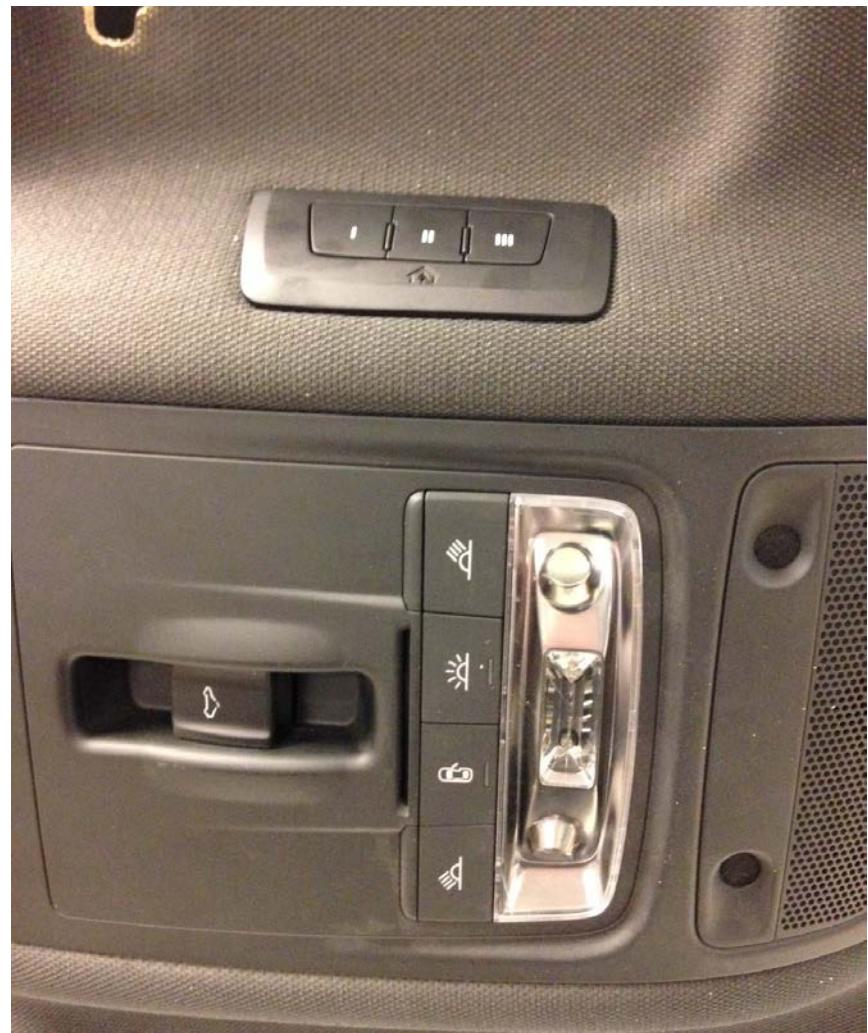
# Q3, A3 HomeLink button inoperative

- HomeLink button(s) inoperative
- Button press requires excessive effort
- Button assembly is loose in headliner

- Button(s) do not depress correctly
- No detent is felt on one of the buttons
- Control unit has become dislodged from the button assembly
- Trim ring broken
- HomeLink button assembly has a parts block and requires a part release from TAC.

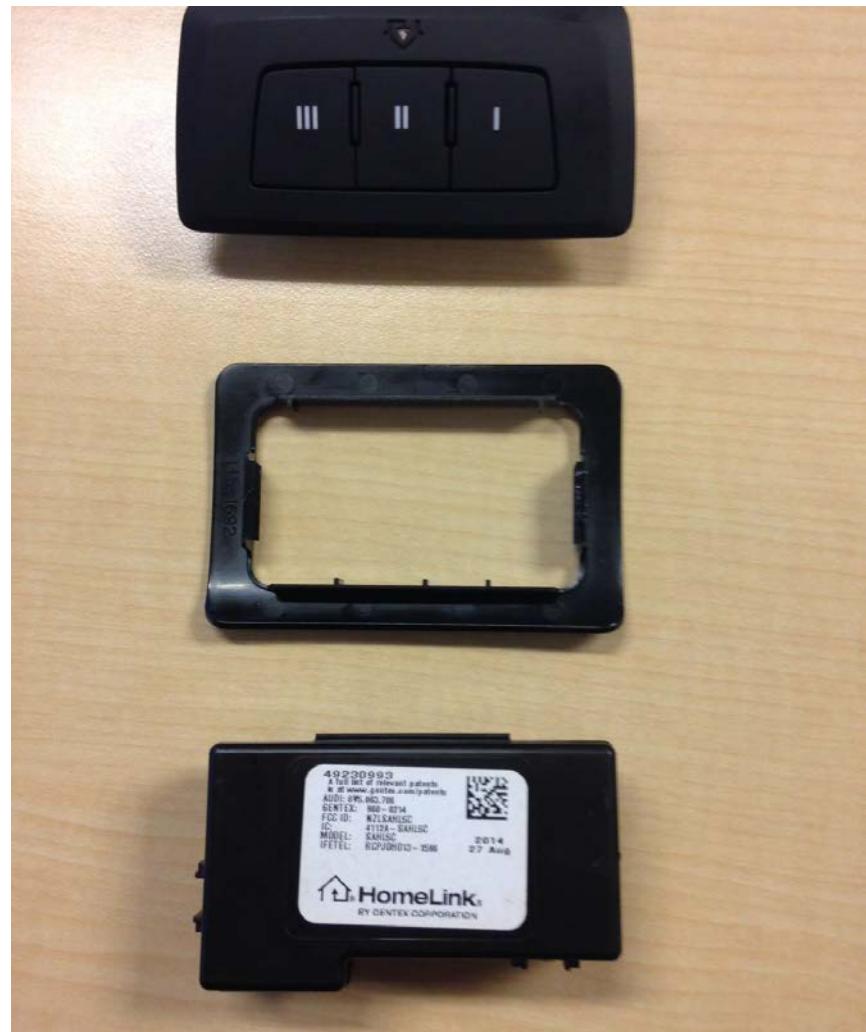
## Q3, A3 HomeLink button inoperative

- Remove the HomeLink module and inspect the assembly for any signs of damage.
- If no damage is found, re-assemble all 3 components on the bench and re-check operation. If the buttons now work, re-install them into the vehicle and check the operation. **Note: No TAC case is required in this case.**
- If damage to any of the components is found OR the assembly easily dislodges again, please take the necessary photos and create a TAC case. Include the photos and part number needed for the parts release.

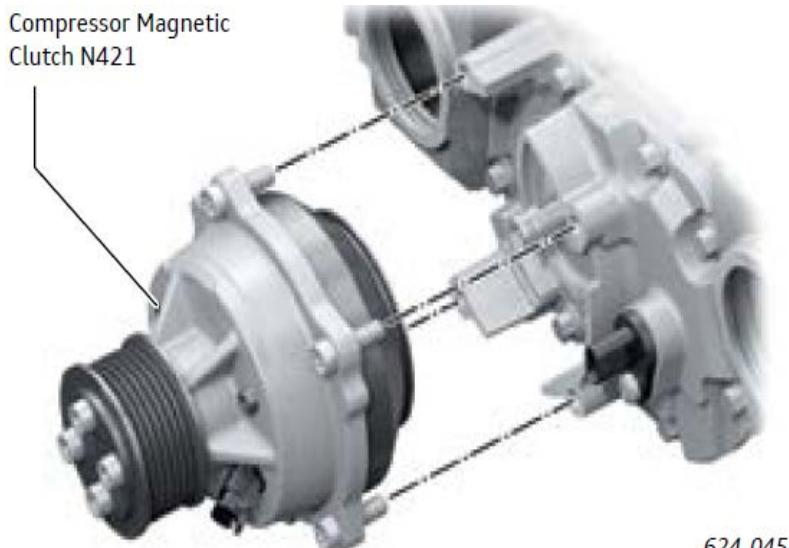
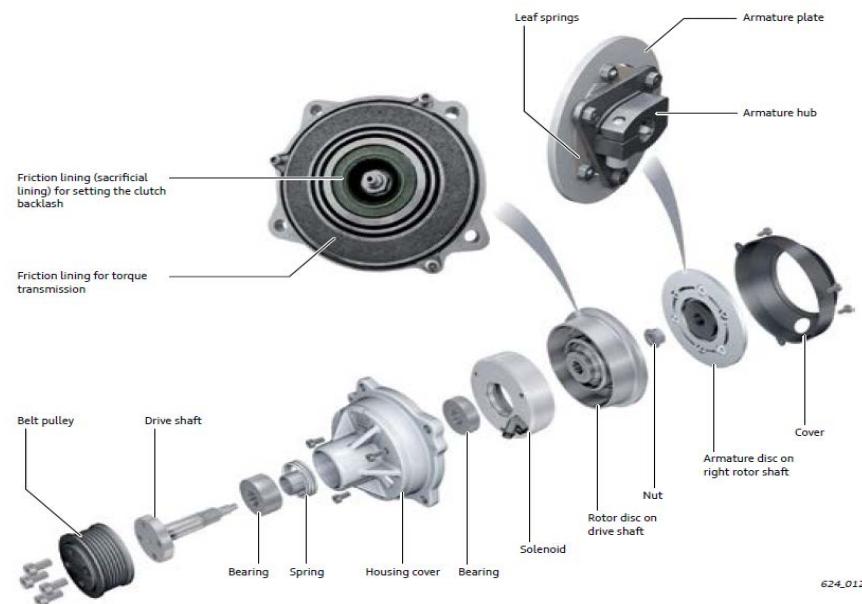
## **3.0 EVO engine supercharger clutch operation**

- In the fourth generation 3.0 TFSI engine, a magnetic clutch has been added to the supercharger drive system. This clutch is similar to an A/C compressor clutch.
- The compressor clutch is not activated at low or medium rpm nor at low engine load conditions.
- When the clutch engages it creates a noise and sometimes a hesitation or shudder on acceleration that may be noticed by the customer. This may result in a complaint and require diagnosis.

A customer may complain about a “hoot” noise initially on acceleration. This noise comes from the clutch engaging. Perform a visual inspection of the clutch and belt. If nothing abnormal is noted then try to verify the concern. Compare to a like vehicle to determine if the noise is normal or not.

When diagnosing a clutch noise concern it is recommended to compare to a like vehicle with similar mileage. Clutch noise at PDI will most likely sound different than a clutch at 10,000 miles for example. The best practice is to drive the concern vehicle and a known good like vehicle for comparison to determine if the clutch is operating normally.

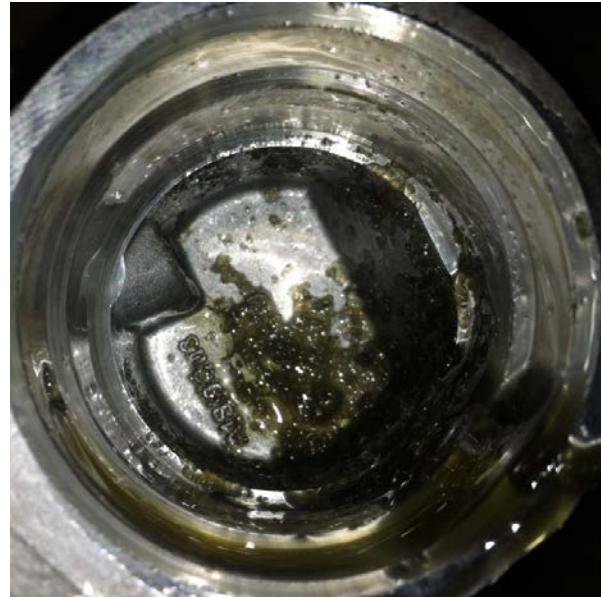
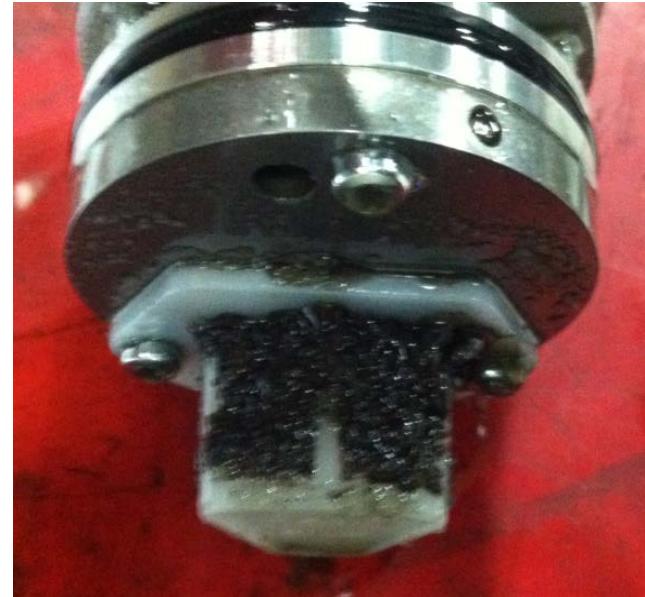
**Cause:** There is an internal leak in the hydraulic pump.

**Note:** There may be debris on the pump when removed. This is normal. You will be flushing the clutch assembly and replacing the fluid during repair.

- Before proceeding, confirm that the issue matches the *Condition* exactly.
- Confirm that the propeller shaft from the transmission to the differential is transmitting power to the rear differential.
- Replace the BorgWarner clutch pump according to the Elsa Repair Manual.
- Replace the high performance oil for the BorgWarner clutch according to the Elsa.
- Perform all-wheel drive basic settings after repairs have been completed.
