<b>Subject:</b> <b>09-025/17 - LEAVING HOME LIGHT FUNCTION DOES NOT WORK</b>	<b>Bulletin No.:</b> 09-025/17
	<b>Last Issued:</b> 06/23/2017

2017 Mazda6 vehicles equipped with speedometer without multi information display (MID) and with VINs lower than JM1 GL \*\*\*\*\* 128622 (produced before January 10, 2017)

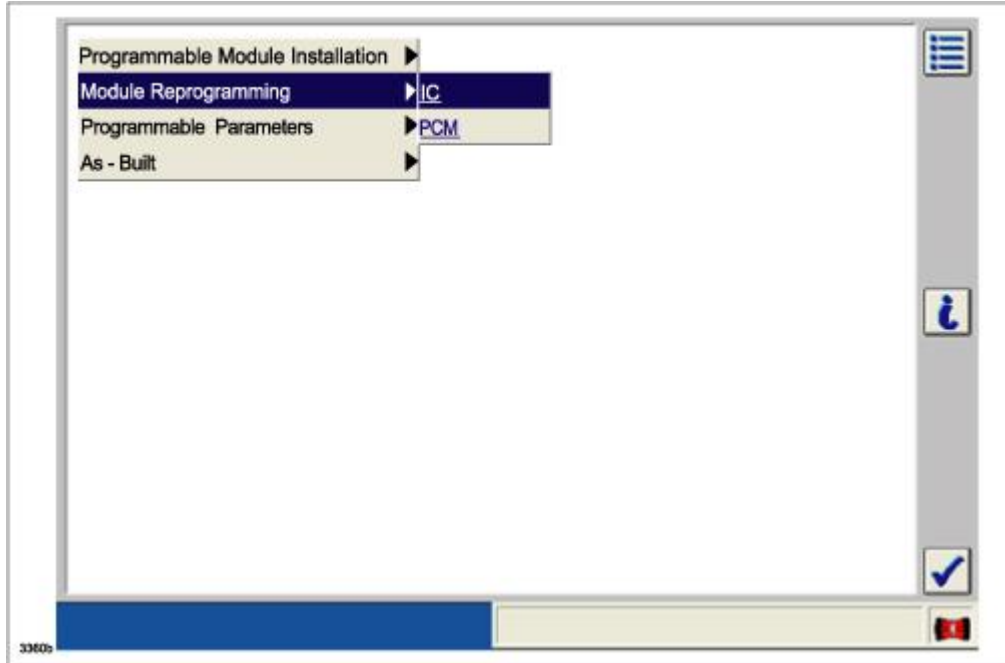
c. The following screen will be displayed:  
Click “YES” and follow the M-MDS instructions to reprogram the IC.

If the message “No later calibration is available on the system for this IC” is displayed, the IC is already at the latest calibration. “Current level in Vehicle” will show the new file name. This service bulletin does not apply.
