Field campaign

| Topic | Convertible Roof System - Oversize Rivet Hole (SC12/13) |
| Campaign number | E773 |

13MY New Continental GTC

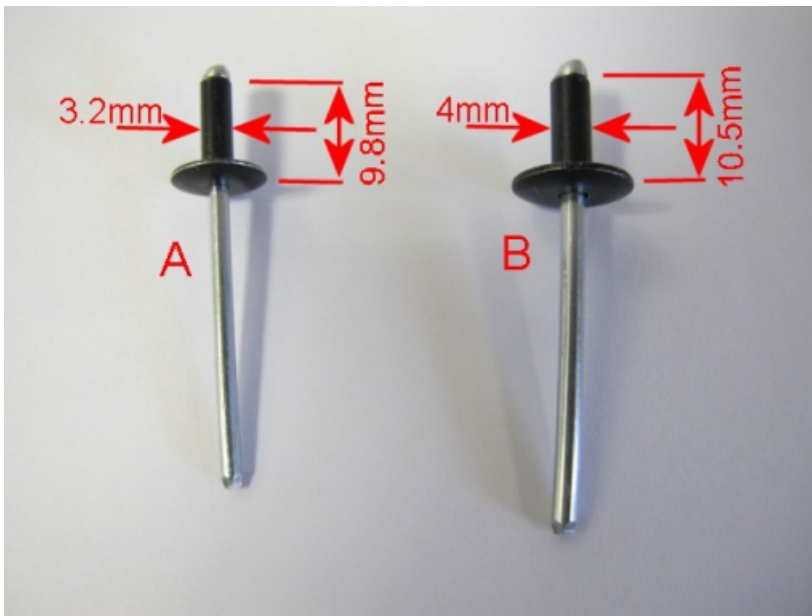
Figure 1

The standard rivet for use where the hole dimensions is found to be correct is 3.2mm x 9.8mm (black) part A

The larger rivet used if the hole is found to be oversize and after the rectification measure has been performed is 4.0mm x 10.5mm (black) part B

**Both these rivets are contained in hood kit 3W7898025**

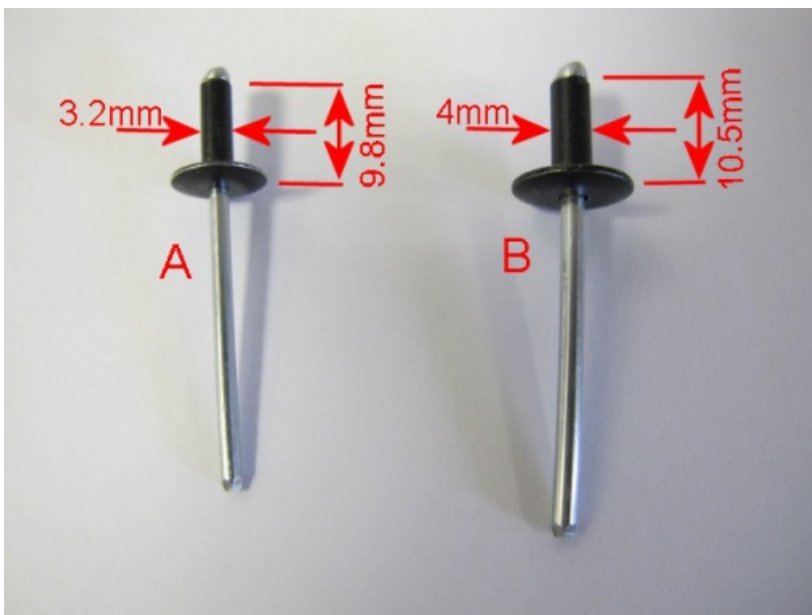
Figure 1

The standard rivet for use where the hole dimensions is found to be correct is 3.2mm x 9.8mm (black) part A

The larger rivet used if the hole is found to be oversize and after the rectification measure has been performed is 4.0mm x 10.5mm (black) part B

Both these rivets are contained in hood kit 3W7898025

the strap with a new standard rivet (part 'A' figure 1) and apply a green campaign completion mark to the rear of the bow adjacent to the replaced rivet. If the drill gauges the hole as 4.5mm at both ends indicating the hole has been counter bored at 4.5mm through its entire length as shown in figure 2 C, then the following rectification measure is required

3. Re attach the strap with a new oversize rivet (part 'B' figure 1) (see Figure 8)
