CAMPAIGN BULLETIN

Automatic Transmission Dealer Inventory

Reference: PC561
Date: April 6, 2017

PC561 – TITAN (A61G, 2WD) MULTI-POINT INSPECTION

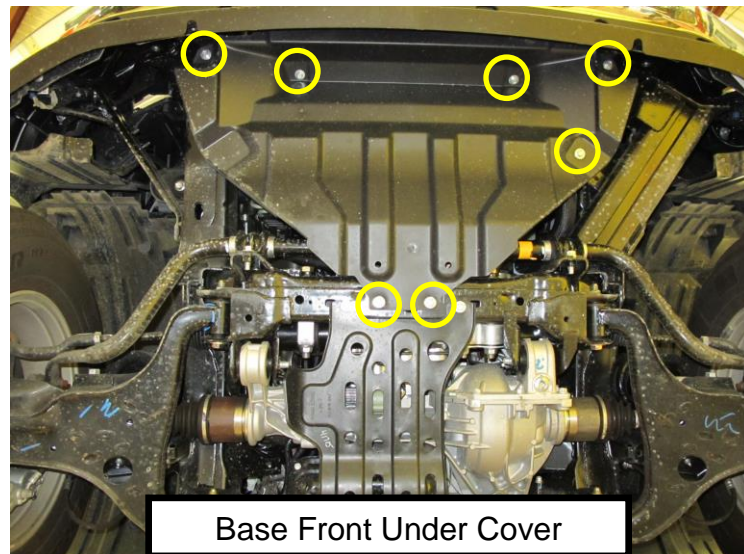
Figure 1

1. Locate and remove the front under cover (Figure 1).
 - Remove the (7) retaining bolts.

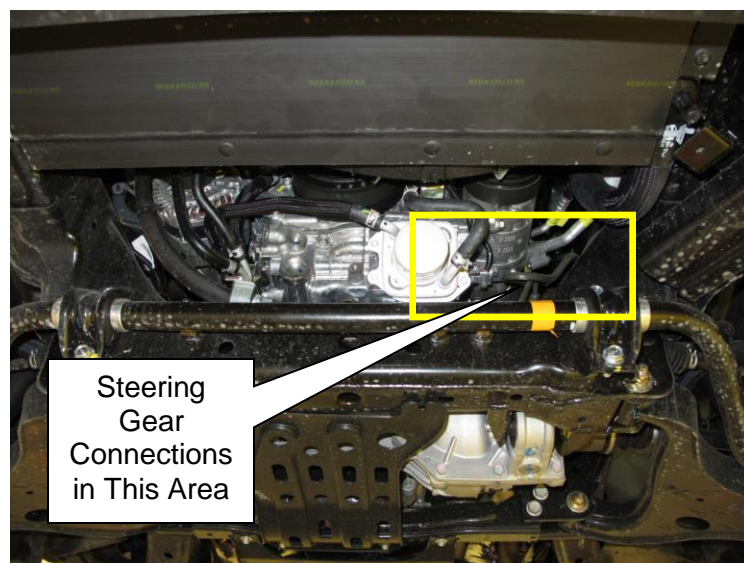
Figure 2

2. Locate the steering gear (rack & pinion) connections for the Power Steering Oil Return Pipe Assembly and Power Steering Oil Pressure Hose Assembly (Figure 2, 3).

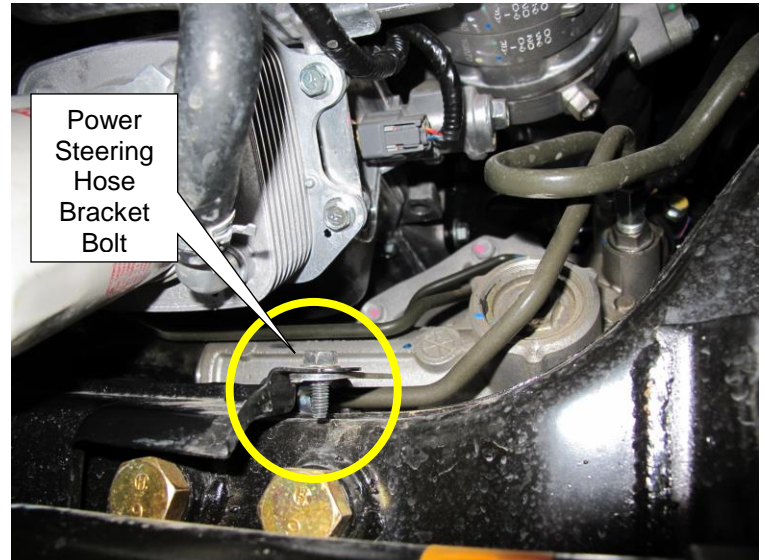
Figure 6

- Remove power steering hose bracket bolt (Figure 6).

- Torque Power Steering Oil Pressure Hose connection to:
33.4N.m (25 ft-lb)
- Reinstall power steering hose bracket bolts: Torque bolts to
9N.m (80 in-lb)

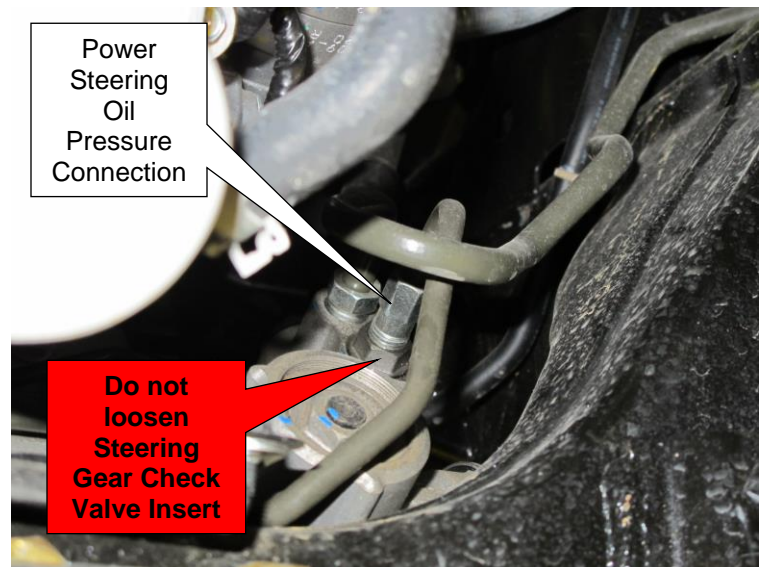
Figure 7

9. Locate the Steering Gear and Power Steering Oil Pressure connection (Figure 7).

Caution: Do not loosen steering gear check valve insert; hold in place while loosening high pressure pipe fitting.

- Loosen connection using a suitable tool.

- Remove old O-ring and replace with Nissan authorized part listed below.

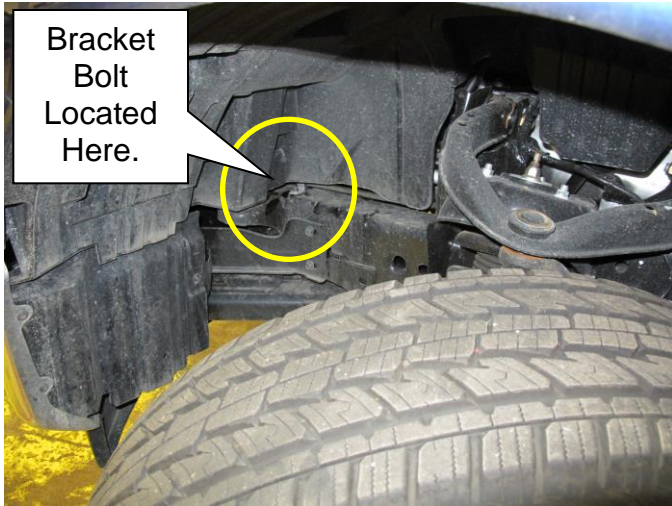
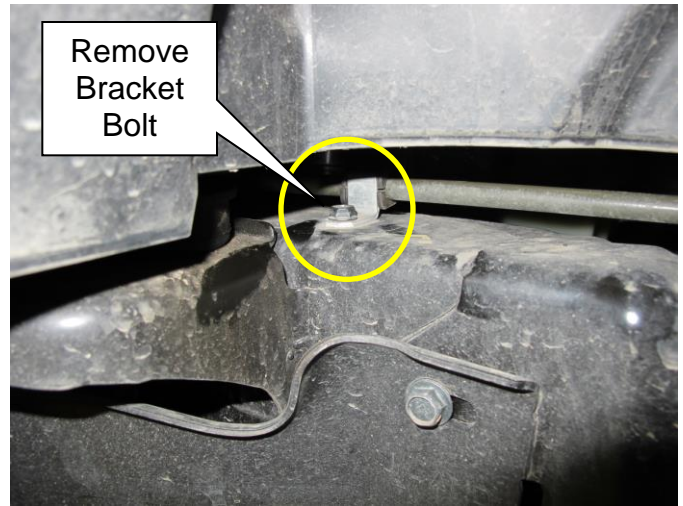
- Remove the power steering oil return line bracket bolt located inside the left fender well on the top of the frame (Figure 8, 9).

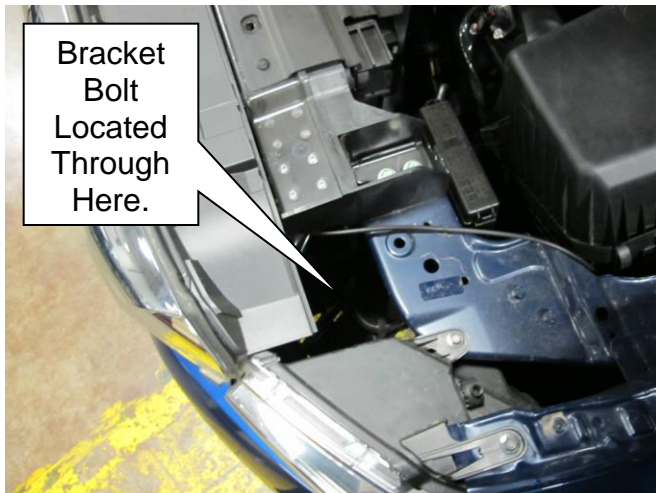
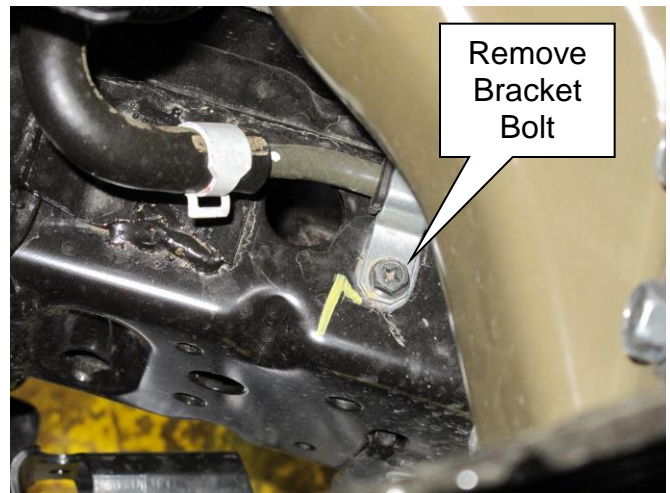
- Remove the power steering oil return line bracket bolt located inside the left front-end body assembly (Figure 10, 11).

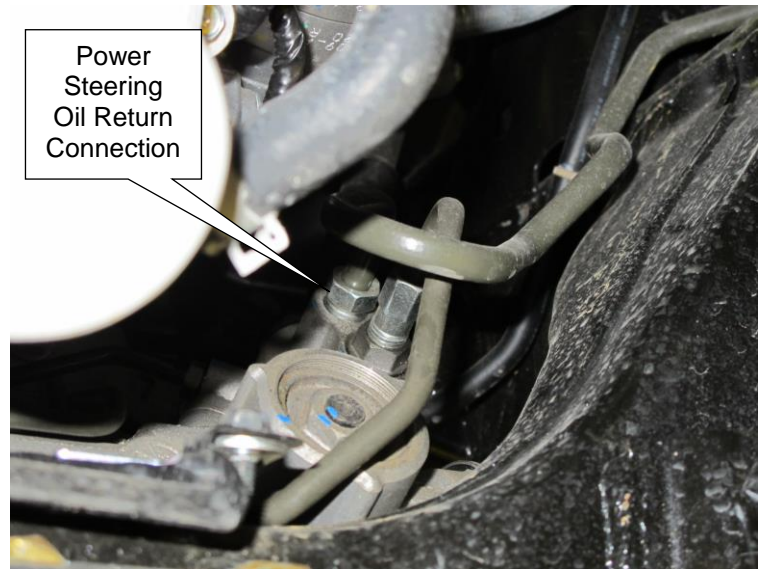
Figure 12

12. Locate the Steering Gear and Power Steering Power Oil Return pipe Connection (Figure 12).

- Loosen connection using a suitable tool.

- Remove old O-ring and replace with Nissan authorized part listed below.

- Torque Power Steering Oil Return Pipe connection to:
19.7N·m (15 ft-lb)

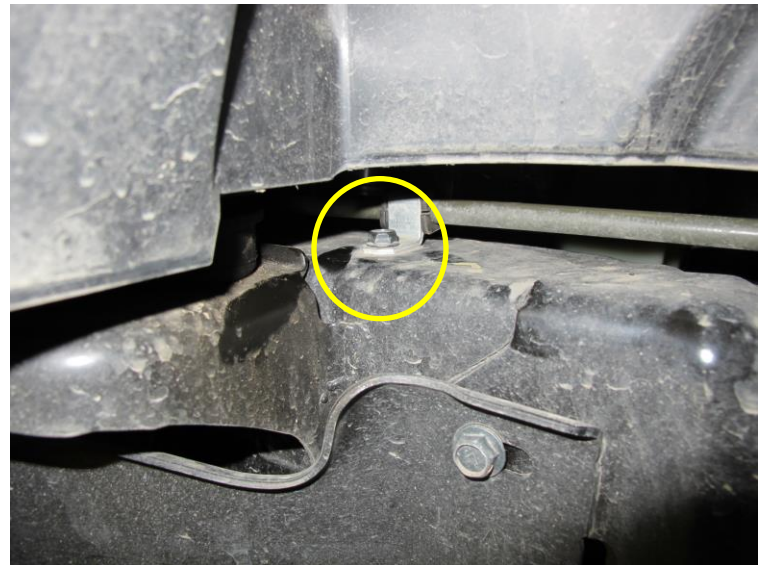
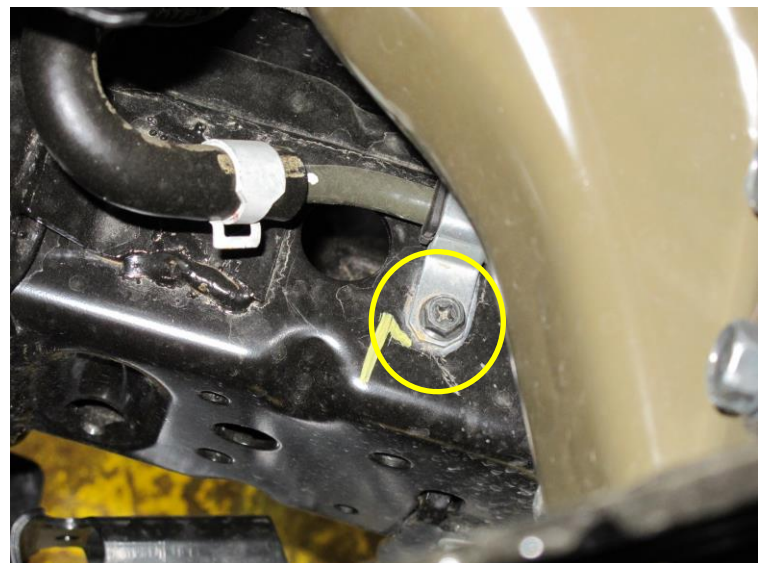
13. Install power steering oil return line bracket bolts (Figure 13,14).

- Torque Power Steering Oil Return Pipe bracket bolts to:
9N·m (80 in-lb)
