SERVICE BULLETIN

Classification: EC17-020	Reference: NTB17-080	Date: July 18, 2017
-----------------------------	-------------------------	------------------------

2014-2016 ROGUE; ROUGH IDLE ON START UP

APPLIED VEHICLE: 2014-2016 Rogue (T32)

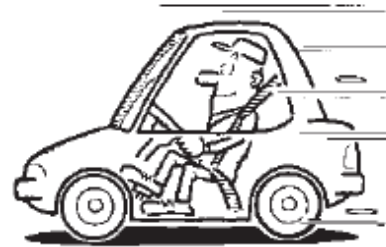
Figure A

- Most instructions for reprogramming with CONSULT-III plus (C-III plus) are displayed on the CONSULT PC screen.
- If you are not familiar with the reprogramming procedure, [click here](#). This will link you to the "CONSULT- III plus (C-III plus) Reprogramming" general procedure.
- Take the vehicle for a 10 minute drive in order to meet the following Idle Air Volume Learn (IAVL) conditions:
 - Engine coolant temperature: 70 - 105°C (158 - 221°F)
 - Battery voltage: More than 12.9V (at idle)
 - Transmission: Warmed up

NOTE: After reprogramming is complete, you will be required to perform Throttle Valve Closed Position, Idle Air Volume Learn, Accelerator Closed Position, and DTC erase. The above conditions are required for IAVL to complete.
