# SERVICE BULLETIN

Classification: EC16-034	Reference: NTB17-082	Date: July 21, 2017
-----------------------------	-------------------------	------------------------

## NISSAN; DTC P0456 CAUSED BY EVAP LEAK AT VENT CONTROL VALVE O-RING

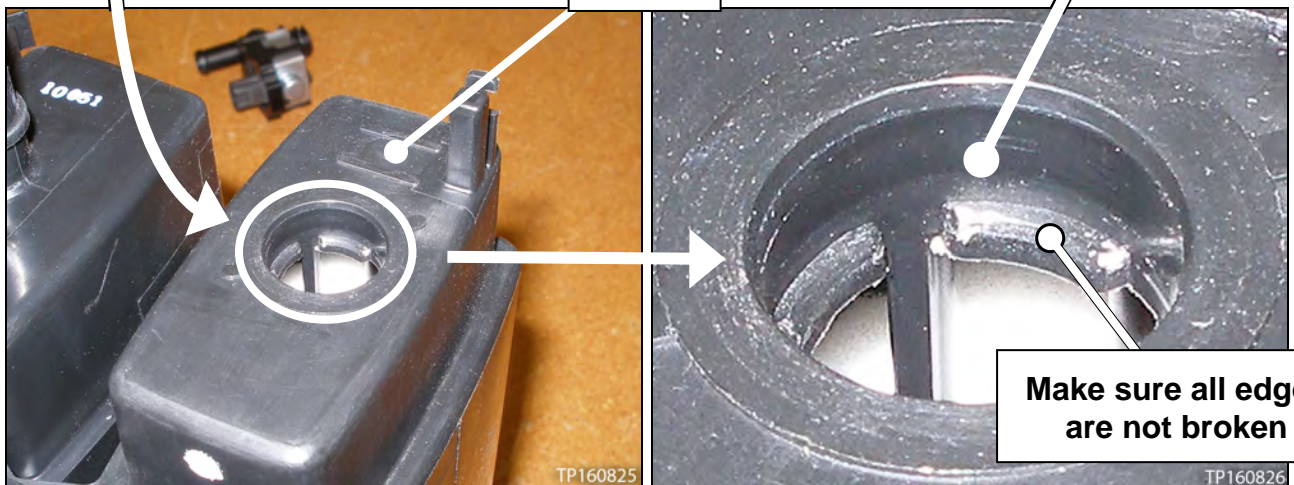
Figure 5

Canister

This surface must be clean all around

- Make sure the surfaces that the O-ring comes in contact with are clean.
- When installed, make sure the O-ring is not twisted or rolled over.
- Verify the repair is complete by checking for leaks with a “smoke” leak detection machine or CONSULT-III plus (C-III plus).
  - If a “smoke” leak detection machine is used, follow the manufacturer’s operating instructions.
  - If C-III plus is used:
    1. Confirm the fuel filler cap is secure.
    2. Connect Essential Tool J-42909 to the EVAP service port.
    3. Using Active Test, close the vent control valve.
    4. Apply pressure using J-42909 until the bar graph reaches about halfway.
    5. Monitor the bar graph for 10 minutes.
