SERVICE BULLETIN

Classification: AT15-015h	Reference: NTB15-086h	Date: October 16, 2017
------------------------------	--------------------------	---------------------------

2013-2014 ALTIMA; MIL ON WITH DTC P0776, P1715 MAY HAVE HESITATION AND/OR LACK OF POWER

APPLIED VEHICLES: 2013-2014 Altima (L33) with 4-cyl engine only

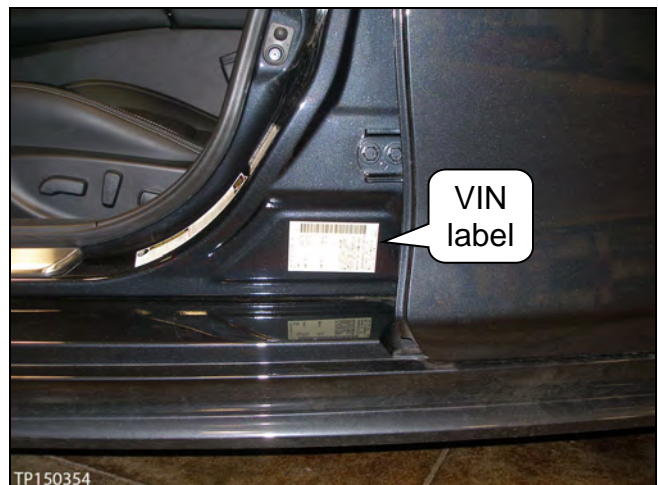
Figure 7

- e. Once CVT replacement is determined as required, use borescope J-51951 to record a 15 second or less continuous video of the most severe evidence of belt slip and the VIN on the F.M.V.S.S. certification label (VIN label). See Figure 7.

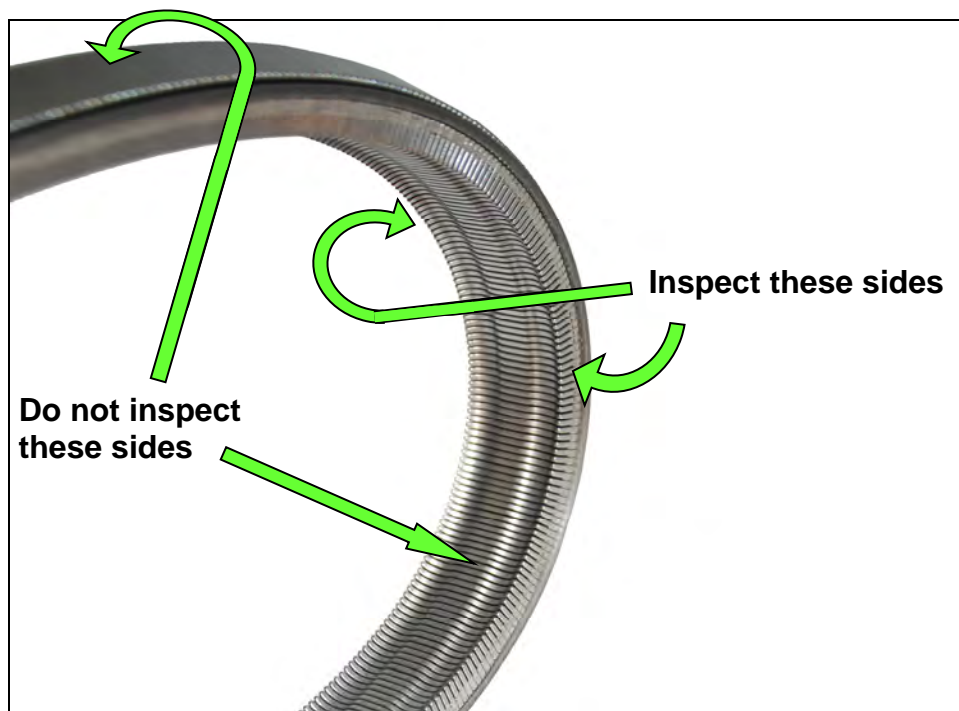
Figure 8

4. Using borescope J-51951 with mirror attachment, inspect the entirety of the two sides of the belt that come in contact with the pulleys (see page 7, Figure 8). Reference the pictures on pages 7 through 11 for comparison.

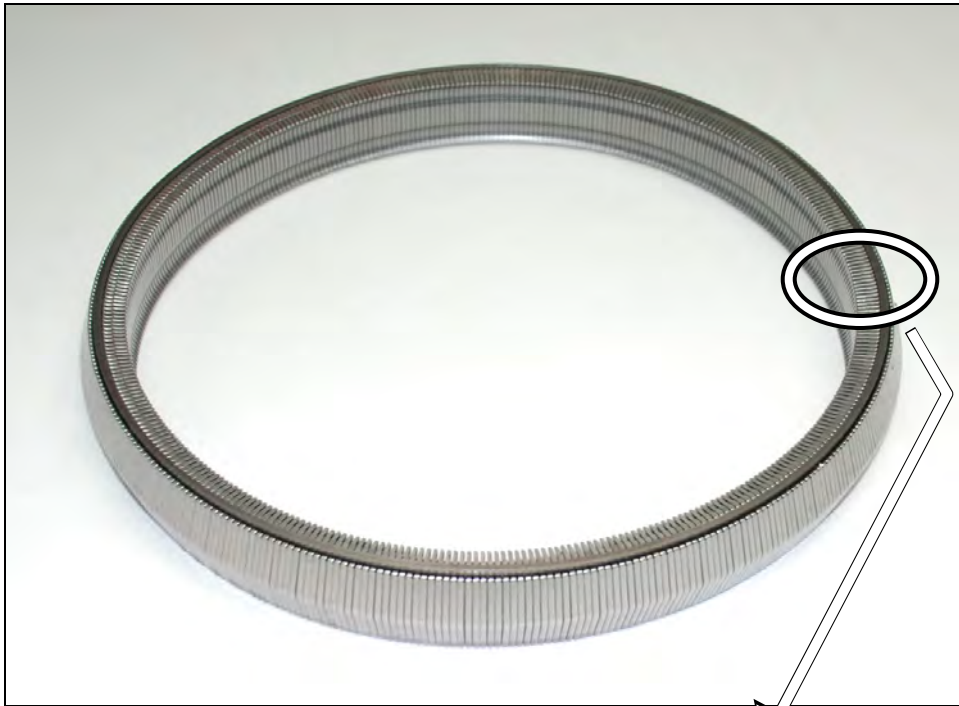
Figure 9: New belt

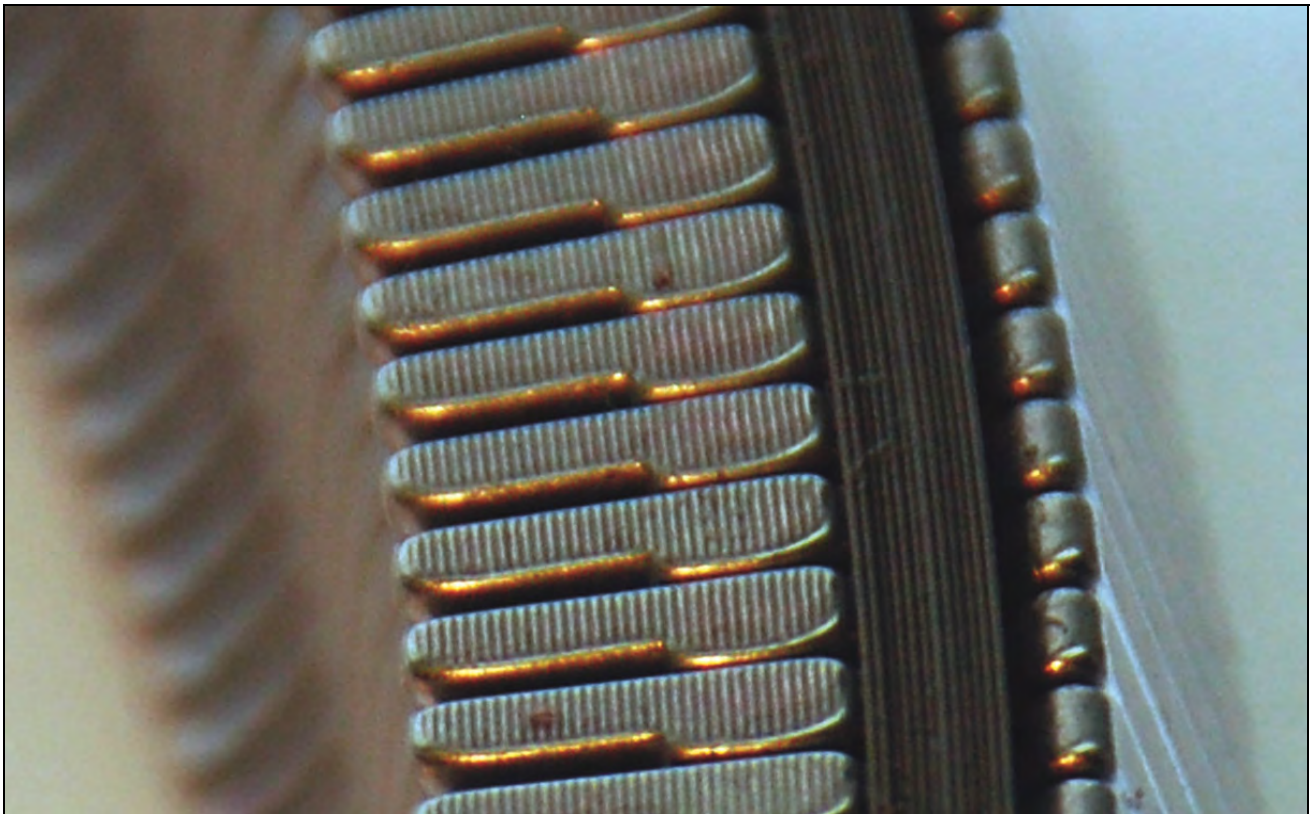
Figure 10: Close-up of section to be inspected
