**TECHNICAL INSTRUCTIONS  
FOR  
SPECIAL SERVICE CAMPAIGN H0P  
INSTRUMENT PANEL WIRE MODIFICATION  
CERTAIN 2017 MY YARIS (A/T)**

**Updated 10-20-17**

In the subject vehicles, an incorrect instrument panel wire harness may have been installed during the vehicle assembly process. The incorrect instrument panel wire harness may not be compatible with the Pre-Collision system front sensor. As a result, the Automatic High Beam and Pre-Collision system may be inoperative.

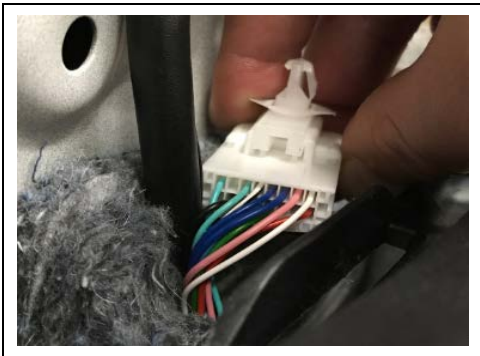
**There are 2 light green wires! Make sure to cut wire that is more toward middle of connector.**

- a. After removal from the body, rotate the clip to expose the wires

- b. Cut the light green wire if the instrument panel wire as close to the connector as possible

- c. Cap the top of the cut wire and crimp it. Securely fasten the cut wire to the instrument panel wire with the vinyl tape
