# Technical Service Bulletin

<b>Subject:</b>  <b>CREAKING NOISE FROM FRONT LOWER ARM BUSHING / CLUNKING NOISE FROM FRONT SHOCK ABSORBER COIL SPRING WHEN DRIVING OVER BUMPS</b>	<b>Bulletin No.:</b> 02-007/17
	<b>Last Issued:</b> 10/06/2017

APPLICABLE MODEL(S)/VINS  
2016-2017 CX-9

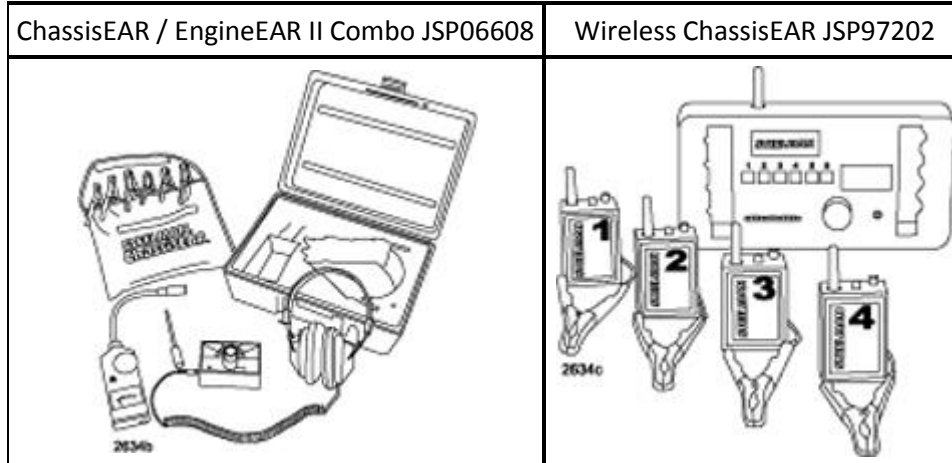
Use Special Service Tools (SST) ChassisEAR / EngineEAR II Combo JSP06608 **or** Wireless ChassisEAR JSP97202 to confirm noise is coming from the front suspension when driving over bumps:
