Technical Service Bulletin

WARNING LIGHT ILLUMINATION OR OTHER SYMPTOMS DUE TO DAMAGED OCCUPANCY SENSOR HARNESS Bulletin No.: 09-040/17

Last Issued: 10/12/2017

2016 CX-5 vehicles with VINs between JM3 KE ****** 600001-752233 (produced before December 09, 2015)

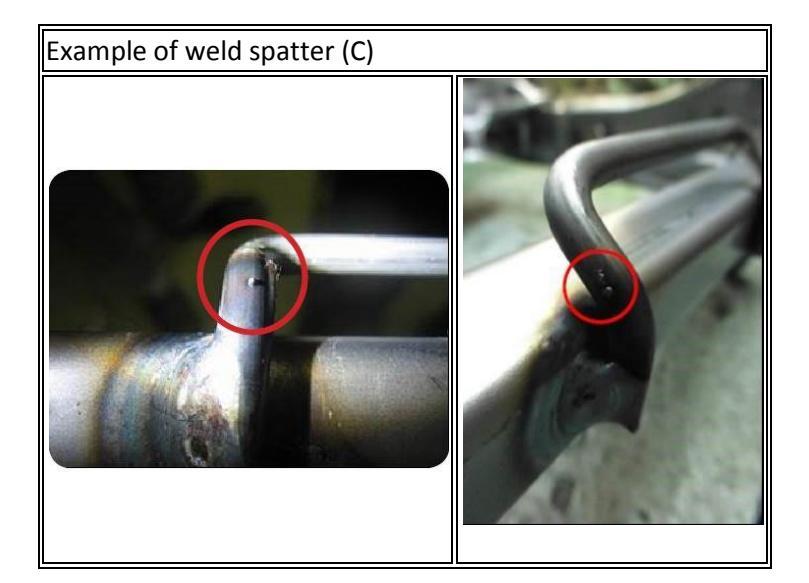
The front passenger seat harness (A) may be damaged by internal seat frame (B) weld spatter. Image below shows possible area of weld spatter (C).

Customers having this concern should have their vehicle repaired using the following repair procedure.
