Park Brake Cable Service Bulletin

Situation: Inner fender placement may affect parking brake cable routing

Corrective Action Summary: Reposition driver's side inner fender and reattach parking brake cable

Range of Units Affected: Aeromaster on the Ford E350 and E450 chassis manufactured between February 2016 and February 2017. Contact Utilimaster Warranty Department to verify chassis VIN.

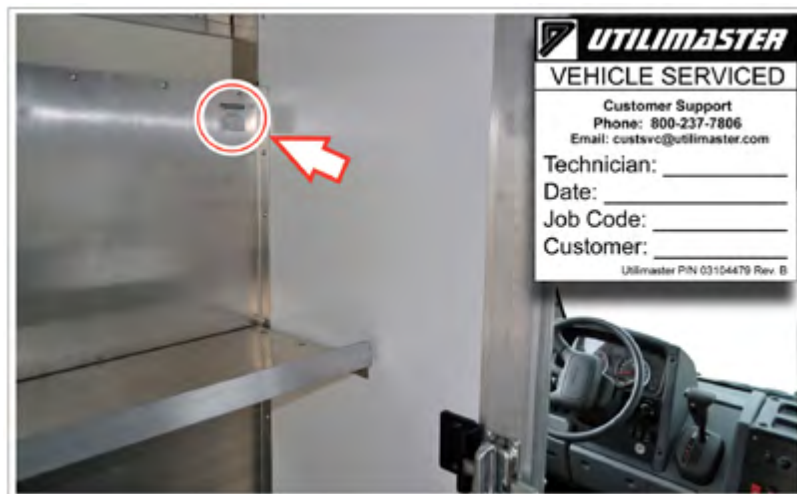
Service decal on driver's door pocket (cargo side)

9. Route park break cable and rivet P-clamp to outboard side of fender.
10. Apply automotive undercoating to coat exposed side of fender. Dry according to manufacturers recommendation.
11. Use Job Code 13-ET-35-31 for inspection and Job Code 13-ET-A7-AI for corrective action from this document to complete the SERVICED decal.
12. Adhere the decal to the upper right-hand corner of the driver's door pocket panel or sidewall next to the bulkhead wall. Do NOT cover any previously applied decals.
