Michael A. Berardi
 Director
 Service Engineering Operations
 Ford Customer Service Division

Supercedes 17N03

October 26, 2017

SUBJECT: **Customer Satisfaction Program 17N03 – Supplement #1**
 Certain 2011-2017 Model Year Explorer Vehicles
 Carbon Monoxide Concerns

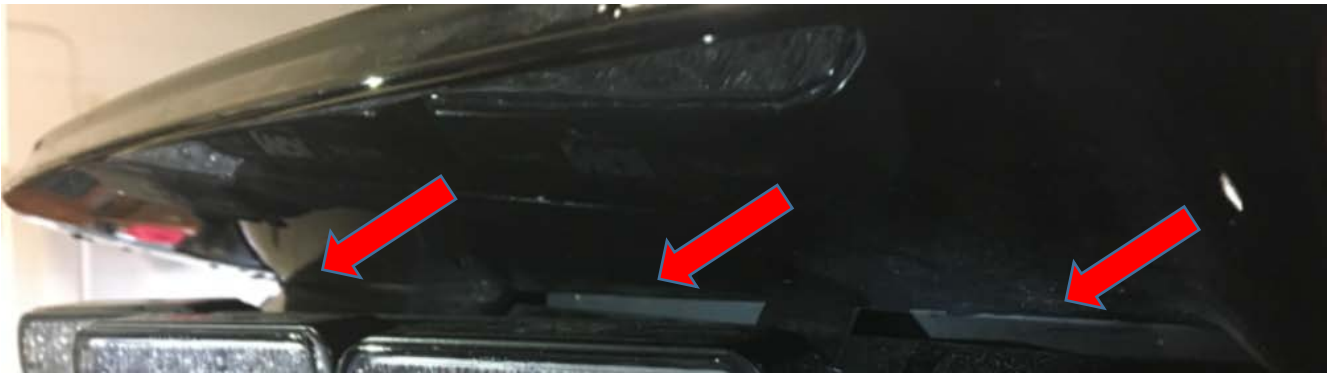
Figure 2

- Brackets positioned between the spoiler and the liftgate (See Figure 1)
- Lighting and/or equipment that forces the spoiler out of position creates a gap between the spoiler and the liftgate (See Figure 2)
- Unsealed holes drilled in the spoiler or liftgate (See Figures 3 and 4)
- Wiring for lighting and/or equipment routed from the spoiler to the vehicle in a manner that damages the seals between the spoiler and the vehicle (See Figures 5 and 6)
- When the spoiler is removed to install aftermarket lights and/or equipment, the spoiler attachment clips and seals may be damaged. If the spoiler was removed from the vehicle, the spoiler attachment clips and seals should be replaced. Use part number HB5Z-78442K03-A
