Technical Service Bulletin

GROUP CAMPAIGN	NUMBER 17-01-057-1
DATE NOVEMBER, 2017	MODEL IONIQ HYBRID (AE HEV)

SUBJECT: TRACTION MOTOR INSPECTION AND REPLACEMENT
(SERVICE CAMPAIGN T2J)

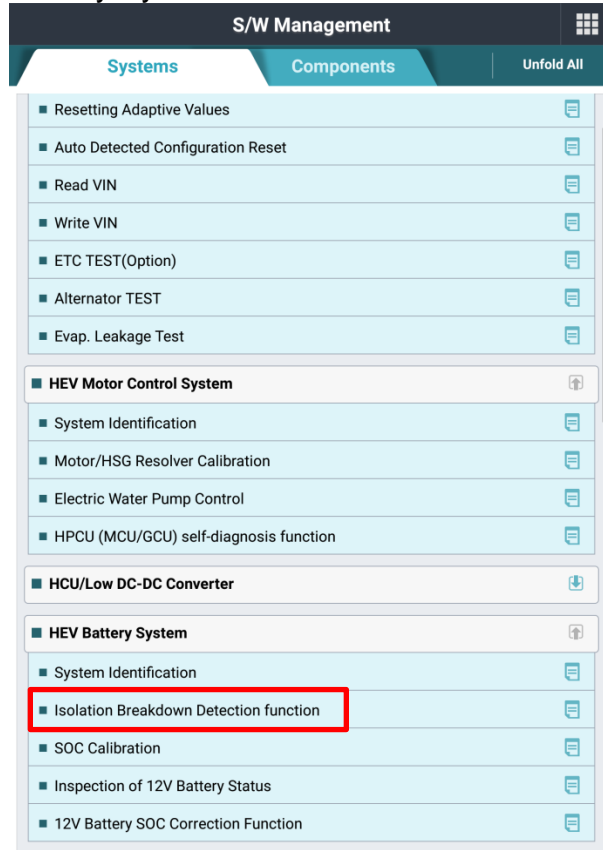
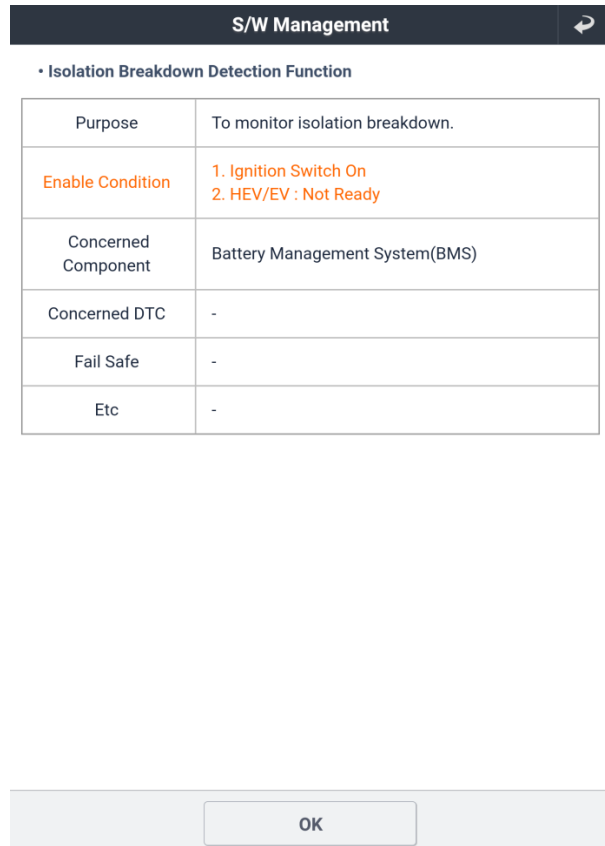
NOTE: The following inspection procedure only applies for vehicles with DTC P0AA6, P0A5F, P0A62 or P0A65 found stored:

Select **Isolation Breakdown Detection Function** within S/W Management section under HEV Battery System as shown in these screens:

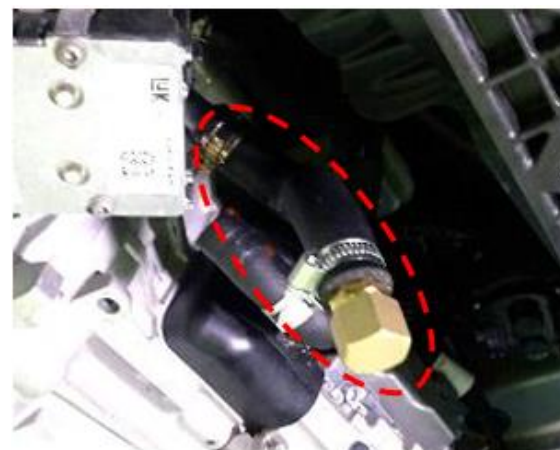
8. a) Raise vehicle on the lift.
b) Connect Adapter Tool hose with the plug to the Traction Motor coolant inlet pipe.
c) Ensure that the hose is secure with the provided clamp so as not to leak any air.

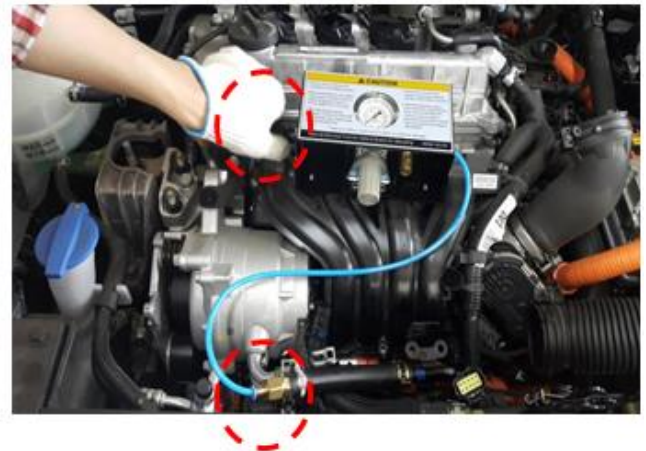
- a) Install the hose (C) into the Adapter Tool quick connect fitting that was attached to the HSG coolant feed tube.
- b) Pull up on the pressure valve (D) and rotate it counter clockwise all the way to the maximum position (lowest pressure).
- c) Install pressurized shop air hose quick connect then open the valve (E).

- d) Set pressure to 3.0 Bar by pushing in and rotating the pressure valve (D) clockwise.
- e) Close the valve (E) once pressure is set at 3.0 Bar and remove the shop air hose.
- f) **Keep valve (E) closed for 5 minutes and observe the final pressure result. Refer to next page for criteria of GOOD/FAILED result.**

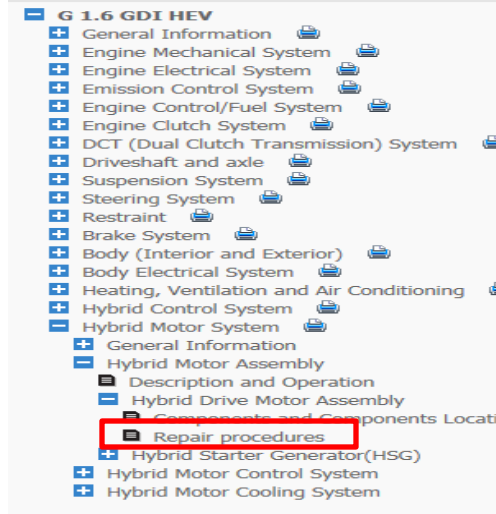
D). Procedure to Replace the Traction Motor in the section Hybrid Motor System:

1. Follow the Shop Manual Procedure located at below:
