GROUP
BODY ELECTRICAL

NUMBER
17-BE-002-G

Technical Service Bulletin

SUBJECT: 2017MY-2018MY GENESIS G80 STANDARD NAVIGATION
VARIANT CODING

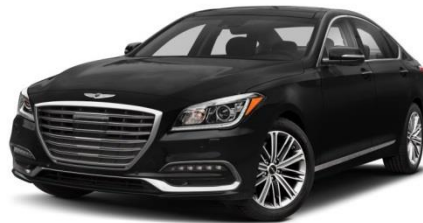
Description: This bulletin describes the procedure to variant code the Genesis G80 (DH) navigation system. A black/blank screen or black and white image may be displayed from the rear view camera after the navigation unit is replaced without performing this variant coding procedure.

Use this information bulletin to variant code the standard navigation system after replacement.
