LTB01065NAS1

TECHNICAL BULLETIN

501-03: Body Closures

Tailgate Does Not Open

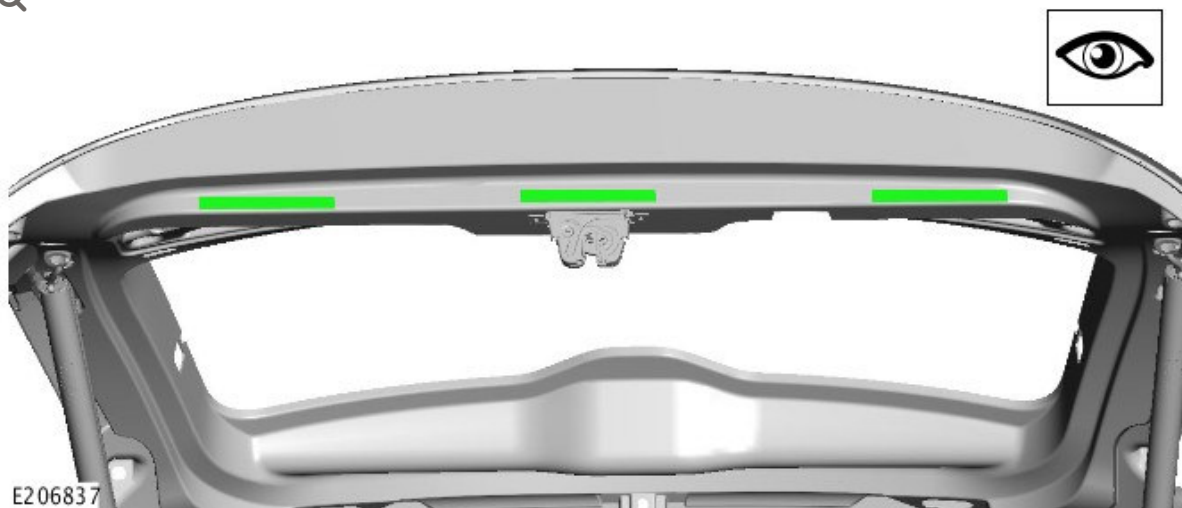
Visually inspect the tailgate.

- If chalk is not visible on the tailgate, go to Step 17.
- If chalk is visible on the tailgate, clean the chalk from the tailgate and go to Step 14.
