**Title:** IC Bus with ISB Frequent Regeneration

**Applies To:** IC Bus ISB

This document will guide the user through resolving Frequent Regen issues on IC Bus with ISB 6.7.

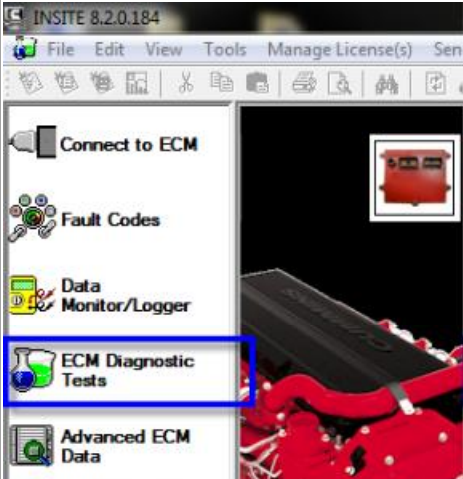
Step	Action	Decision
2	<p><b>DIAGNOSTIC:</b></p> <p>Using Cummins Insite software, run the Rise over Ambient test (found in ECM Diagnostic Tests tab).</p>

<p>Is the ROA greater than 20F?</p>	<p><b>Yes.</b> Go to Step 3</p> <hr/> <p><b>No.</b> Article does not apply</p>
