Commercial Vehicle Technology
Axle and Transmission Systems for Buses and
Coaches

Potential quality defect in the wheel bearing assembly of ZF axles of the type A/AV/AVN

ZF Quality issue - wheel bearing assembly

Checking of slotted nut-hub bolt connection on A 132, AV 110/132/133, AVN 132

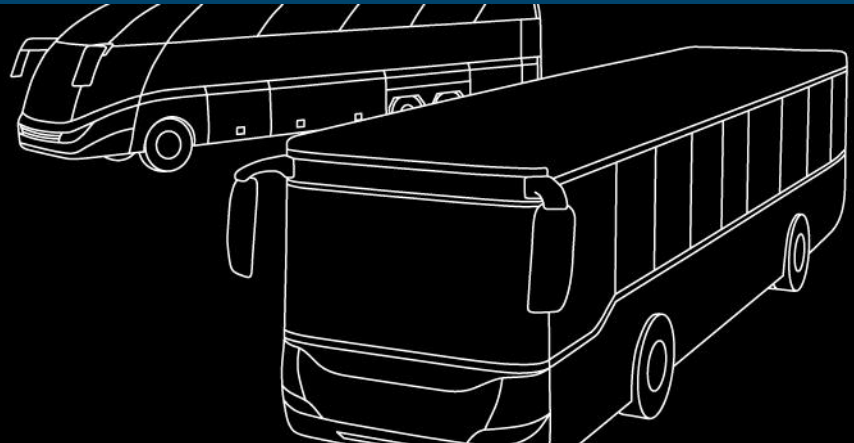
Wheel bearing assembly

- The wheel heads of the rear axles A/AVN/AV are locked by a system of two slotted nuts and a tab washer. The inner slotted nut is tightened with 850 Nm and the outer nut with 1200 Nm. The tab washer between both nuts is used as locking device additionally to the countering of the two nuts
- Within an evaluation of screwing data of the wheel bearing assembly in October 2016 a high variation of the screwing angles of the slotted nuts has been detected. Because of this an intense root cause analysis and elimination process has been started.
- The investigations revealed that on some axles a settlement in the bearing assembly had occurred which could result in a loss of tightening torques of the threaded connections during operation and also a damage to the locking plate. This has also been verified by checks on axles in the field which had been selected by suspect screwing angles.

- Disassembly of the wheel head threaded connection (slotted nuts), replacement of locking plate and re-assembly of the slotted nuts. Details see ZF service bulletin 80-17.
