HYUNDAI Technical Service Bulletin	GROUP BODY ELECTRICAL	NUMBER 17-BE-017
	DATE DECEMBER, 2017	MODEL(S) SONATA (LF) TUCSON (TL)
SUBJECT: AVN 4.0 APPLE CARPLAY PHONE CALL ECHO DEFECT

Applicable Vehicles:	<ul style="list-style-type: none"> • 2016MY Sonata (LF) equipped with AVN 4.0 • 2016MY Tucson (TL) equipped with AVN 4.0
-----------------------------	--

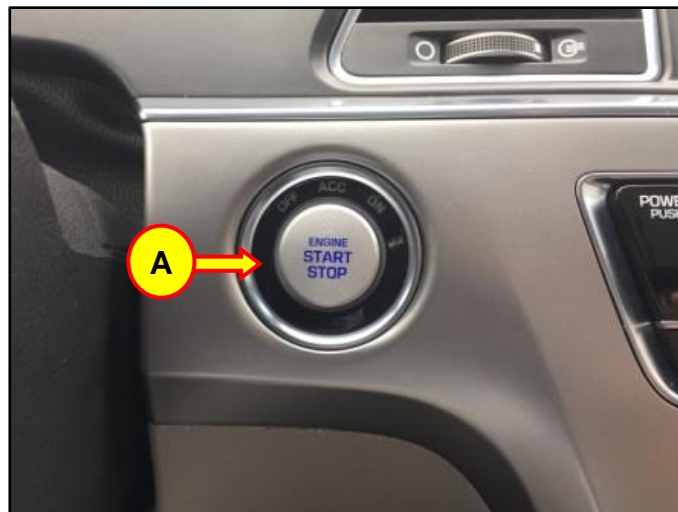
1. Depress the brake pedal and press the **START STOP BUTTON (A)** to start the vehicle.

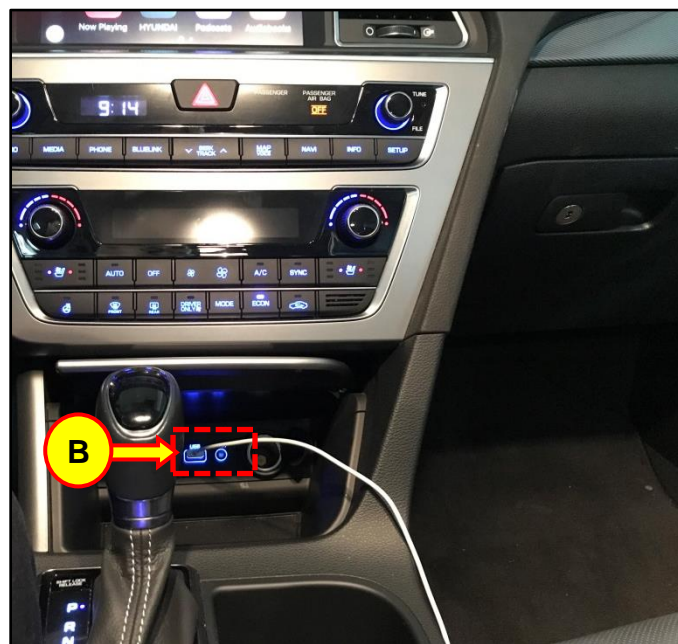
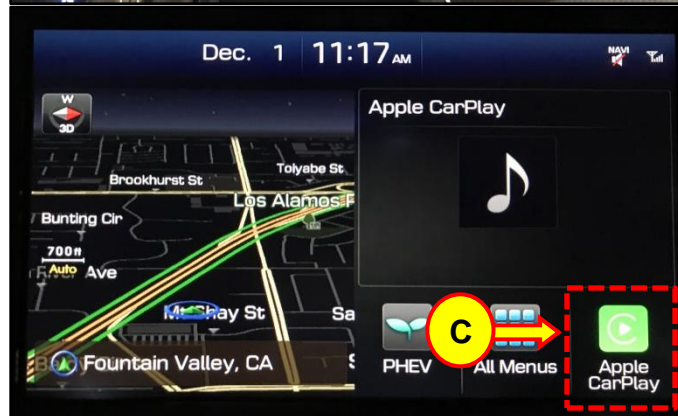
2. Plug an Apple iPhone into the USB port located in the front center console (B) and open Apple CarPlay on the head unit display (C).

Make sure Apple CarPlay is enabled in the vehicle settings.
