GROUP BOD	MODEL 2016MY Cadenza (VG)
	NUMBER 171	DATE December 2017
TECHNICAL SERVICE BULLETIN		
SUBJECT: CLUSTER FASCIA PANEL REPLACEMENT

SUBJECT: CLUSTER FASCIA PANEL REPLACEMENT

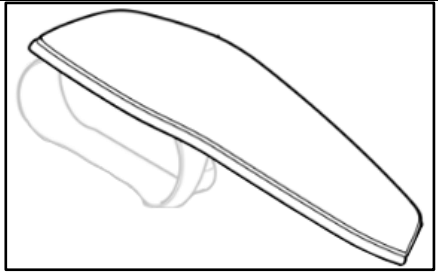
Part Name	Part Number	Figure
Cluster Fascia Panel	84830 3RAC0CAFFF

1. Replace the cluster fascia panel by referring to the “Body (Interior and Exterior) → Interior → Crash Pad → Repair procedures” chapter in the applicable Shop Manual on KGIS.
