## INSTRUCTION TO SERVICE

**ITS: 6722**

| <b>SUBJECT:</b> | "NABI" – MGM E-Stroke Harnesses |

# ITS6722

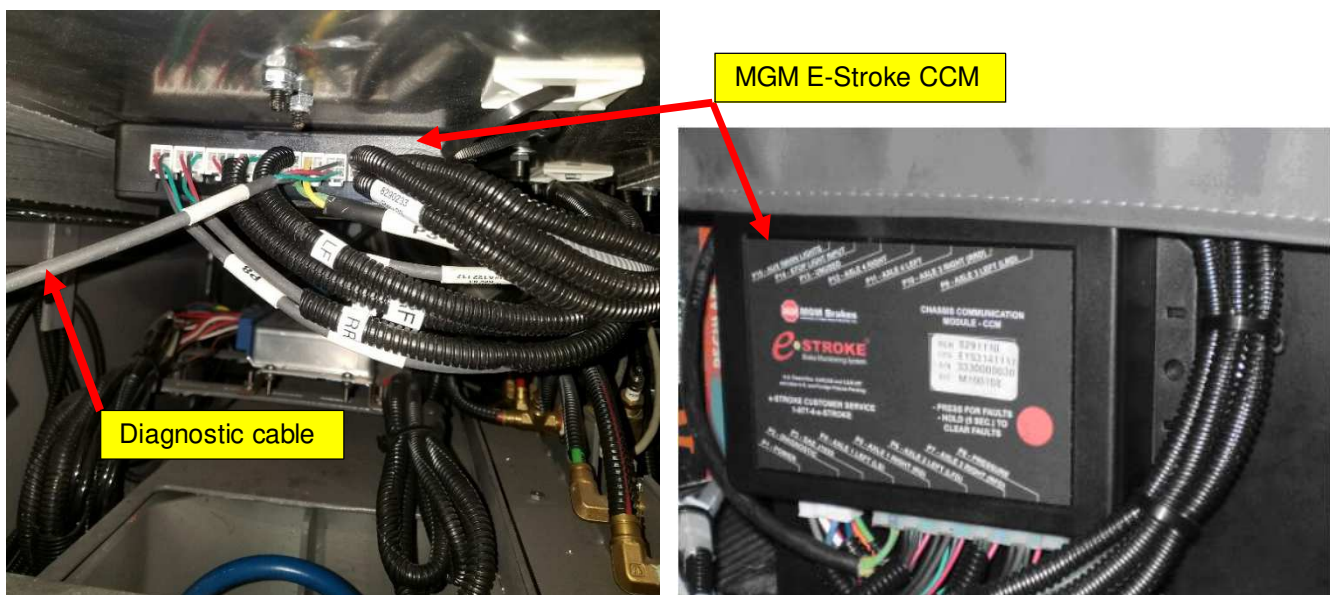
**Figure 1: E-Stroke CCM – Gen 3 version is shown**

1. Park bus on a flat surface and apply the parking brake.
2. Open the radio compartment door and locate the MGM E-Stroke CCM. Refer to Figure 1.

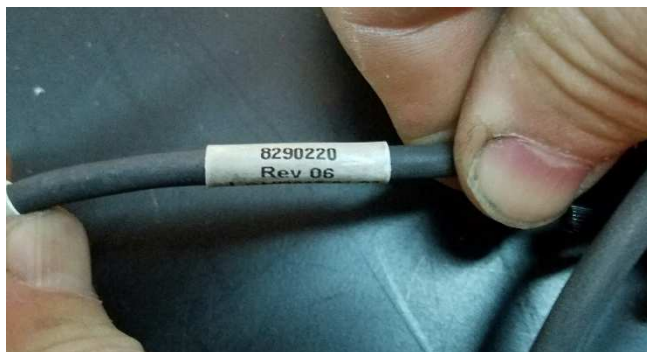
**Figure 2: E-Stroke diagnostic cable – Gen 3 version is shown**

3. Connect laptop equipped with the latest MGM E-stroke software to the diagnostic port. Ensure to use the correct software and cable supplied with the E-Stroke system installed on your bus. Refer to Figures 1 and 2.
