MODEL: Karma Revero**DATE:** December 2017**TITLE:** Front Door Glass Fitment Inspection and Adjustment**First Release****PRIORITY:** On Complaint**APPLICABILITY:** MY17 and MY18 Revero**MARKET REGION:** North America**PURPOSE:** Remedy for possible wind noise complaint

Technical Service Bulletin

TB-17-76-21

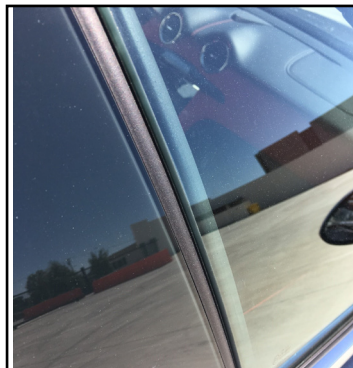
1. Verify condition of window glass, it must sit flush against the seals on the body when in the full up position and the door closed. The gap to appliqué should be 10 to 11.5mm and parallel along the glass edge.

Adjustment requires the glass clamp screws to be loosened, glass adjusted and re-tightened to 10Nm.

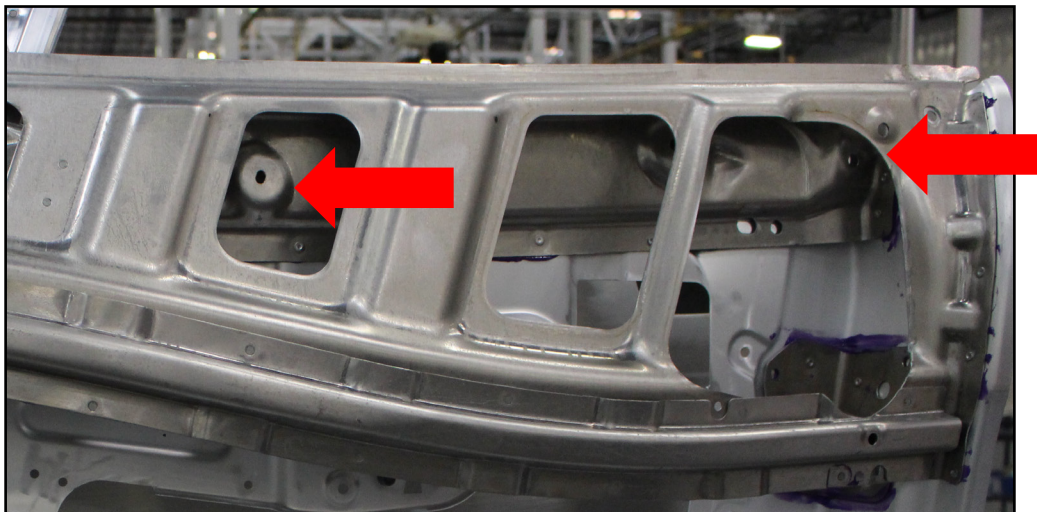
fig 7b

A bare door assembly shown here to better identify the regulator mount position (fig 7b).

- 5) Check the upper regulator mounts for shims- if required remove shims to check adjustment this may be sufficient (fig 7a). However verify that glass movement speed, up and down in the channel is not affected, as the glass may now contact the seal and create some drag. You may find one (1) or (2) shims in each position, trial should first be done removing 1 shim and checking glass to B pillar flushness and for satisfactory glass speed, if this is still unsatisfactory remove the second shim and recheck.
