## SERVICE BULLETIN

Classification: EC16-036b	Reference: NTB16-117b	Date: December 7, 2017
------------------------------	--------------------------	---------------------------

### 2016-2017 ALTIMA; MIL ON WITH A/F RATIO SENSOR DTC(s)

**APPLIED VEHICLE:** 2016-2017 Altima (L33)

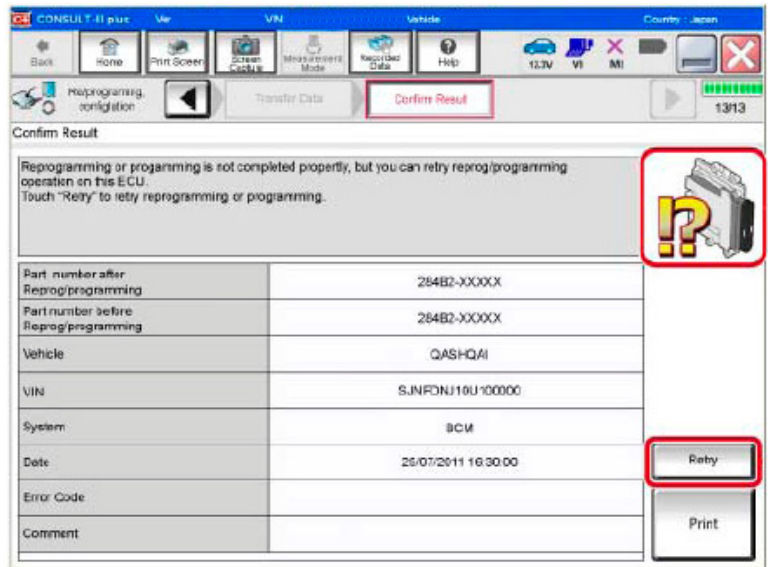
Figure 16

If reprogramming does not complete and the “!” icon displays as shown in Figure 16:

- Check battery voltage (12.0–15.5 V).
- Ignition is ON, engine OFF.
- External Bluetooth® devices are OFF.
- All electrical loads are OFF.
- **Select retry and follow the on screen instructions.**
- “Retry” may not go through on first attempt and can be selected more than once.

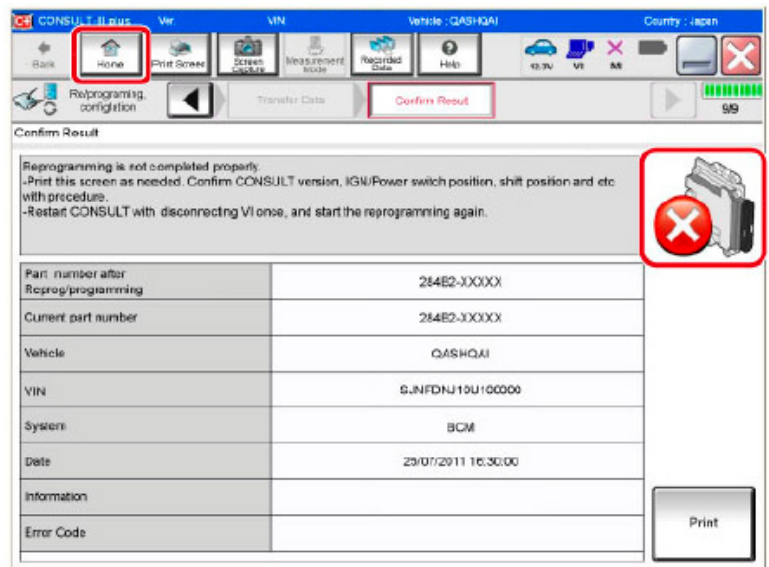
Figure 17

If reprogramming does not complete and the “X” icon displays as shown in Figure 17:

- Check battery voltage (12.0 – 15.5 V).
- CONSULT A/C adapter is plugged in.
- Ignition is ON, engine OFF.
- Transmission is in Park.
- All C-III plus / VI cables are securely connected.
- All C-III plus updates are installed.
- **Select Home, and restart the reprogram procedure from the beginning.**
