Technical Service Bulletin

9106 UPDATE – Q7 Update Package MMI, Steering Column and Sunroof (NVLW)

August 22, 2017

Model(s)	Year	VIN Range	Vehicle-Specific Equipment
Audi Q7	2017	See Campaign/Action screen in Elsa	None

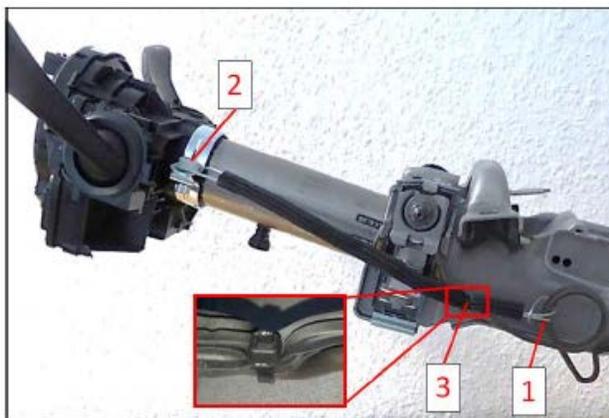
Summary of steps performed:

1. Loop on securing cable
2. Secured to nut
3. Fixed in place by cable tie.

12. Cut off protruding end of cable tie so that it is flush <A>.
