# Technical Service Bulletin

## 28H3 UPDATE – Quality Package (NVLW)

August 29, 2017

Quality improvement measures must be performed on Audi A4 vehicles manufactured within a specific period.

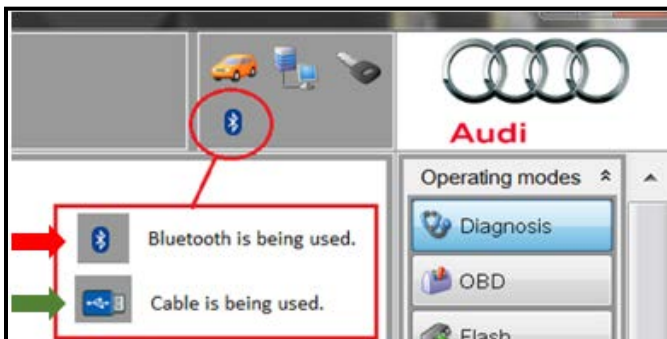
4. Attach the scan tool to the vehicle using an USB cable.
5. Confirm that the scan tool is communicating with the diagnostic head by USB <Green Arrow>. If the Bluetooth symbol is shown <Red Arrow> then disconnect the diagnostic head from the vehicle and then reattach the USB cable to the diagnostic head and then reattach to the vehicle.

6. Using Flashing, perform the update using the SVM action code, **28H3A384**.
