# Technical Bulletin

**24 17 02** February 15, 2017 **2045138** This bulletin revision supersedes V241701 dated January 4, 2017 and allows archiving of, technical bulletin 2031075 (V241208) dated December 17, 2012 and 2038161 (V241506) dated October 1, 2015.

**MIL ON DTCs P2004, P2014 and or P2015 Stored in ECM Fault Memory**

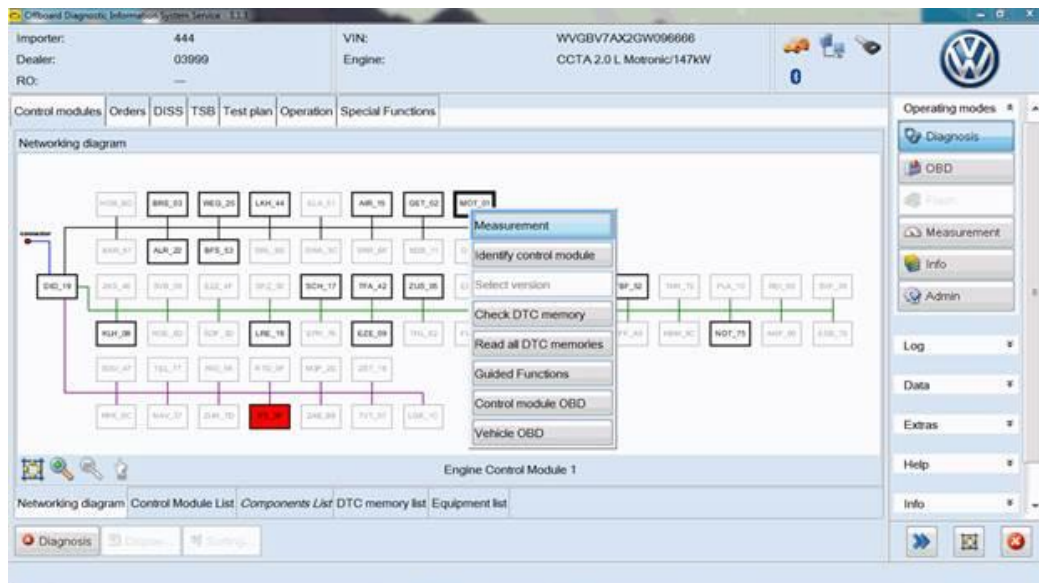
Figure 4

- Check the diagnostic limits of the flap with the ODIS tester.
- Under Motor, select Guided Functions (Figure 4).

If the adaptation is not successful, the flap stop is worn internally, the intake manifold also has to be replaced. See Repair Group 24 Multiport Fuel Injection in Elsa.
