Technical Service Bulletin

Subject: ACCESSORY ROOF RACK DIFFICULT OR CANNOT INSTALL	Bulletin No.: 09-047/17
	Last Issued: 12/18/2017

APPLICABLE MODEL(S)/VINS 2016-2017 CX-3

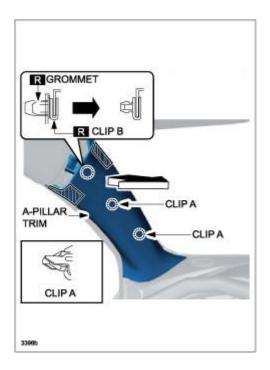
PARTS LOCATION:

Part Number	Description	Qty.	Notes
GJ6A-56-47ZE	Roof Carrier Bracket	1 - 4	
D09W-68-162	Clip, Trim	2	Non-reusable part

2. If anyroof carrier bracket(s) are not installed correctly, remove the affected bracket(s) and install new ones in the correct direction, according to the ROOF CARRIER BRACKET REMOVAL/INSTALLATION instructions.

NOTE: All four (4) roof carrier brackets must be installed so the arrows face inward.
