**Title:** DM harness inspection

**Applies To:** 0005710 STRG COL, TILT & TELE

iKnow for inspecting DM harness for damage, and correct routing

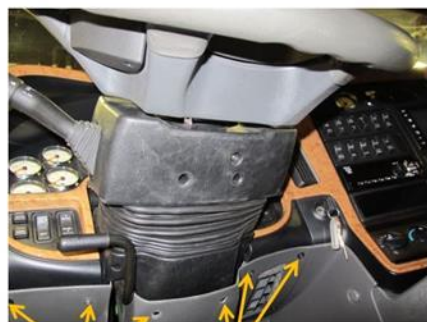
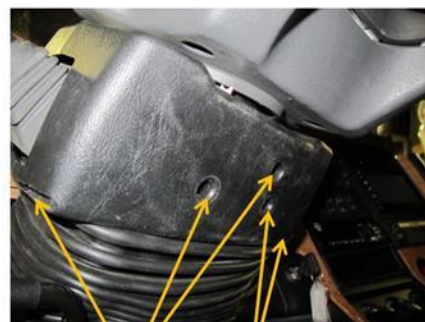
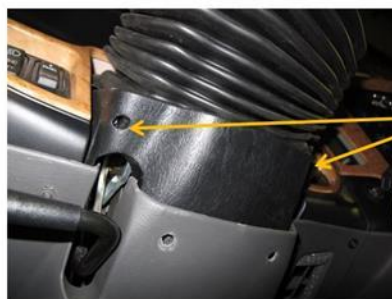
**Figure 1: removal of cowl**

Screws  
Close-out panel

Screws  
Column Covers Upper

Screws (one on each side)  
Column Cover Lower

Using a Torx T-20 driver, remove the screws from the column covers and the lower close out panel (if applicable).

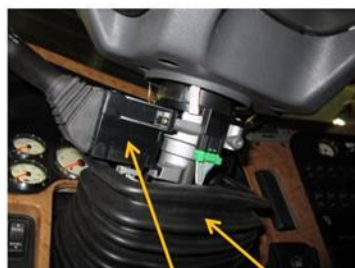
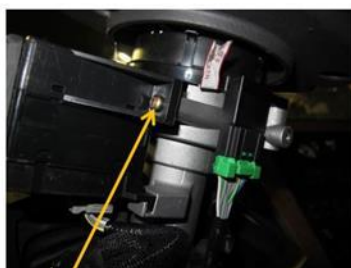
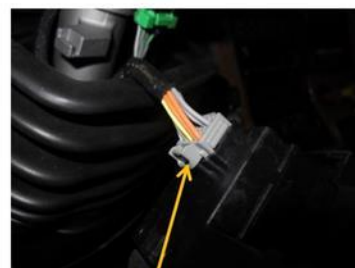
Figure 3: Reroute procedure

Multi-function switch Boot

Screws (one on other side)

Multi-function switch electrical connector

Remove the upper covers. Move the boot downward, if needed. Then, using a Torx T-20 driver, remove the two screws from the multi-function switch (turnsignal).

Then, unplug the electrical connector from the multi-function switch (turnsignal).

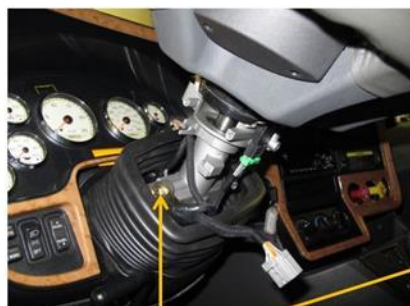
Bracket screws
