Emissions Recall

Code: 23V6

Subject	3.0L TDI Engine Emissions System Modification – Customer Only (Retail Sold) TDI Vehicles <u>USA ONLY</u>		
Release Date	November 6, 2017		
Affected Vehicles	<p>U.S.A.: 2013-2014 MY Volkswagen Touareg 3.0L TDI Generation 2.1</p> <p><i>Check Campaigns/Actions screen in Elsa on the day of repair to verify that a VIN qualifies for repair under this action. Elsa is the <u>only</u> valid campaign inquiry & verification source.</i></p> <ul style="list-style-type: none"> ✓ Campaign status must show “open.” ✓ If Elsa shows other open action(s), inform your customer so that the work can also be completed at the same time the vehicle is in the workshop for this campaign. 		
Problem Description	3.0L TDI vehicles were equipped with undisclosed Auxiliary Emission Control Devices which are not permitted by emissions regulations.		
Corrective Action	Install updated engine control module (ECM) software, transmission control module (TCM) software and hardware to bring affected vehicles into regulatory compliance.		
Code Visibility	On or about November 6, 2017, affected vehicles will be listed on the Inventory Vehicle Open Campaign Action report under My Dealersh

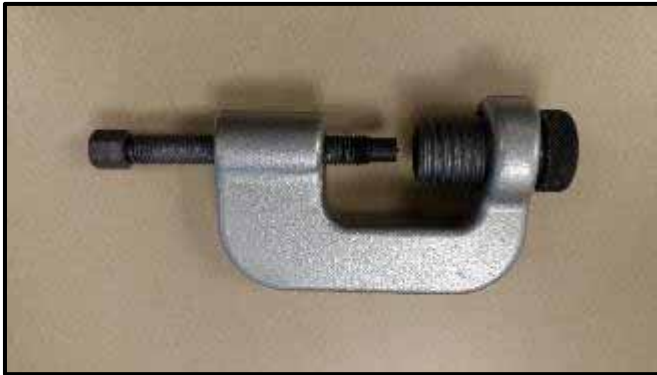
Due to corrosion, one or more of the mounting studs may break <arrows> when removing the SCR catalytic converter from the Diesel Particulate Filter (DPF) flange. Follow the steps below if one or more studs are broken or damaged.

DO NOT use a hammer and punch, heat, air hammer, or other method to remove the studs from the DPF. Consequential damage to the DPF or ancillary components **will NOT be covered** under this action due to damage from heat, impact, or vibration.

- If stud replacement is necessary, use a commercially available clevis pin press, such as an OTC 5057 (shown) or equivalent to press any broken or damaged studs out of the DPF flange.
 - It is advised if one stud breaks that all three studs are pressed out and replaced with the bolts/nuts included in the parts kit.
- Install the replacement bolts and corresponding nuts into the rear DPF flange.

Part Number	Description	Quantity
N 01024713	Replacement Exhaust Bolt	3
N 91130802	Shouldered Hex Nut	3

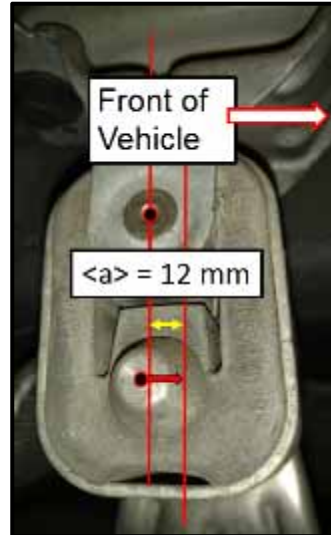
In order to reduce harmonic vibration, the rear muffler/resonator straps <A> require 12 mm of forward tension, as shown in the sub-photo. Pull forward on the rear muffler/resonator pipe and insert the pipe deeper into the Dual Clamp until this dimension is achieved.

- Once the desired dimension of <a> = 12 mm is achieved, tighten the Dual Clamp nuts to 23 Nm.
