# Emissions Recall

## Code: 23V6

<b>Subject</b>	<b>3.0L TDI Engine Emissions System Modification</b>
<b>Release Date</b>	November 29, 2017
<b>Revision Summary</b>	<b>Updated resale information included.</b>
<b>Affected Vehicles</b>	<p><b>U.S.A.: 2013-2014 MY Volkswagen Touareg 3.0L TDI Generation 2.1</b></p> <p><i>Check Campaigns/Actions screen in Elsa on the day of repair to verify that a VIN qualifies for repair under this action. Elsa is the <u>only</u> valid campaign inquiry &amp; verification source.</i></p> <ul style="list-style-type: none"> <li>✓ Campaign status must show "open."</li> <li>✓ If Elsa shows other open action(s), inform your customer so that the work can also be completed at the same time the vehicle is in the workshop for this campaign.</li> </ul>
<b>Problem Description</b>	3.0L TDI vehicles were equipped with undisclosed Auxiliary Emission Control Devices which are not permitted by emissions regulations.

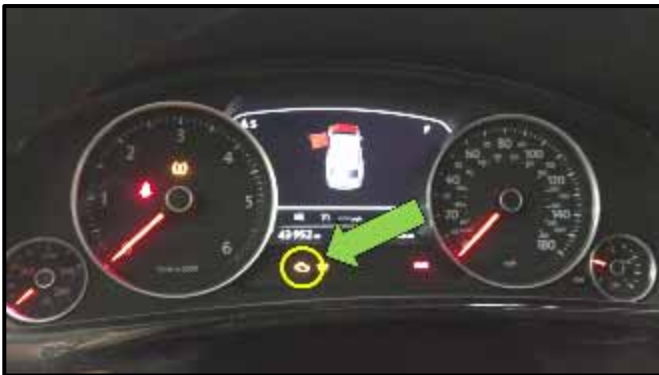
- If vehicle modifications from original equipment related to emissions components are not found, continue the work procedure.
- Check for illumination of the MIL <arrow>.

- If MIL is illuminated, **STOP**, create a VTA ticket and contact the Volkswagen Technicians Helpline.
  - If MIL is not illuminated, continue the work procedure.
