# Customer Satisfaction Program

## 17328 Radio Module Software Update

**Reference Number:** N172117760

**Release Date:** November 2017

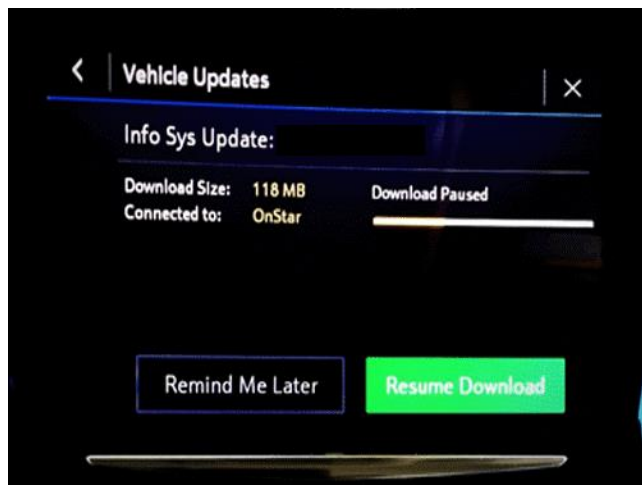
4880803

- From the radio home screen, select “Settings” then “Vehicle Software”. Under “About”, locate the Build Number. If the build number is anything other than 20.9, proceed with software update.

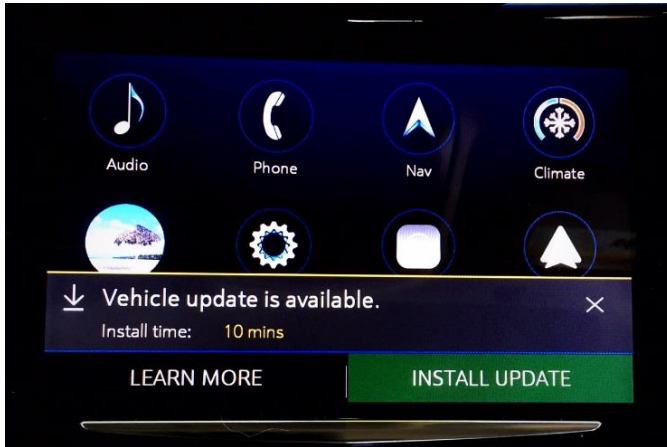
4880808

1. Start the vehicle to determine if the update has been downloaded to the radio. The vehicle must be running for the update screen to be shown.
  - If the radio has downloaded the remote vehicle update and the radio is ready to be updated, the screen above will be shown when the vehicle transitions to park. Select Install Update and follow on the on-screen prompts.

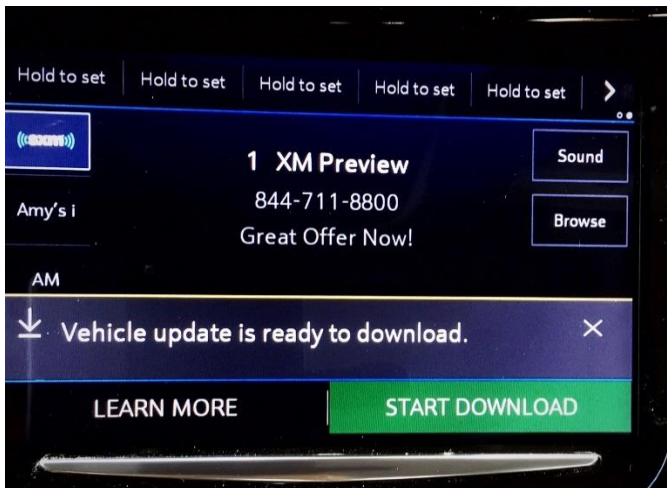
4880809

- If the remote vehicle update has not been downloaded, select "Start Download" as shown above.

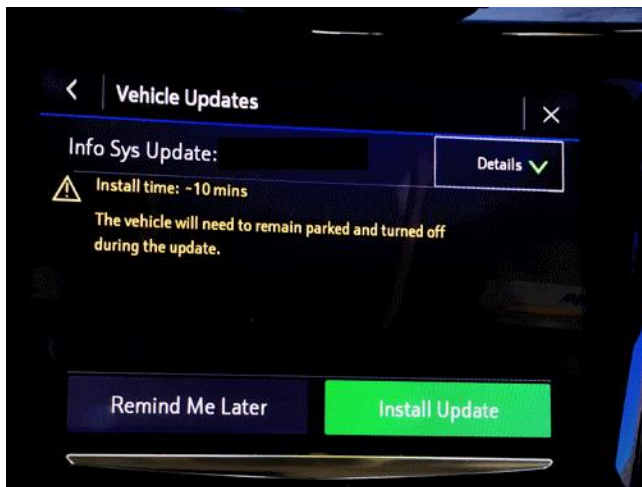
4880822

- If the vehicle needs to download the remote vehicle update file or the “Install Update” screen does not appear, select “Settings”, scroll down to “Updates” and select “Updates” to download the remote vehicle update.
- If there are no updates available, verify the software version. If the build number is anything other than 20.9, update through USB.

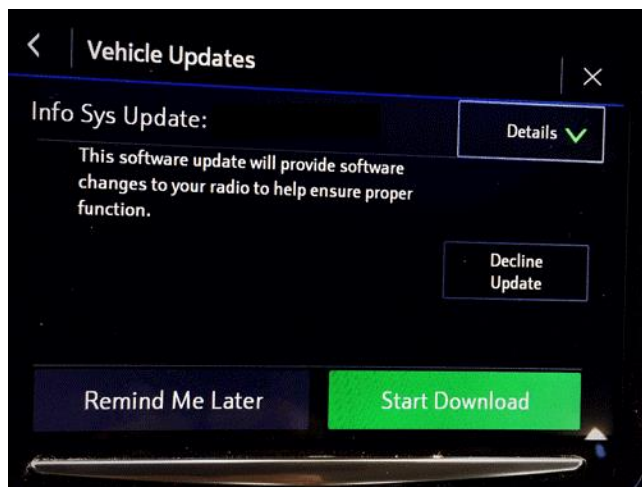
4880805

1. Before downloading begins, be sure the driver side door is either closed or the driver side door latch is closed.
2. Go to “Settings”, then “Updates” to determine if there is already a Remote Vehicle Update installed, the package must be deleted.

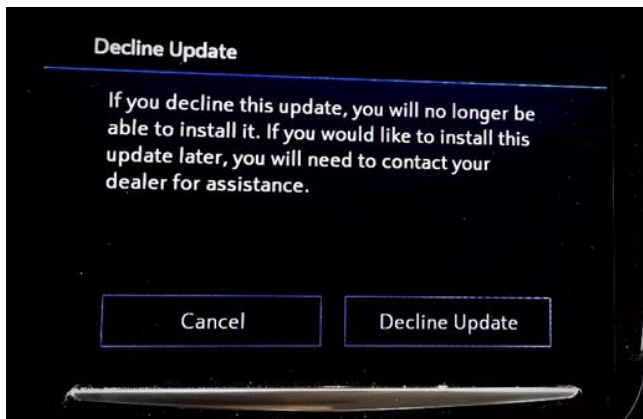
4880807

- 2.1. If a Remote Vehicle Update exists on the vehicle, click “Details,” to reveal the Decline Update option.
- 2.2. To delete the Remote Vehicle Update, click on “Decline Update”. On the next screen, click “Decline Update” again.

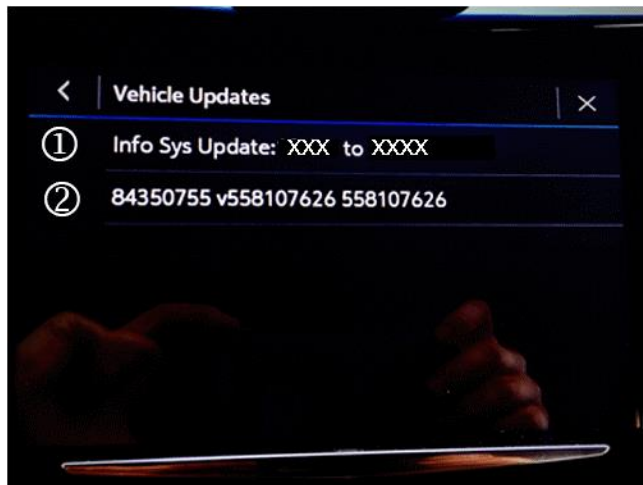
4880825

6. If a Remote Vehicle Update exists on the vehicle and has not been declined, the screen above will be displayed. Select the “Info Sys Update” option and follow steps 1.1 and 1.2 to decline the update before continuing with the USB update.
7. Once the Remote Vehicle Update has been declined, select the USB file (2) to continue programming the SPS update.
