SERVICE ACTION: INSPECT / REWORK DME CONNECTOR

This Service Information bulletin replaces SI B12 17 17 dated **October 2017**

F30 (3 Series Sedan)

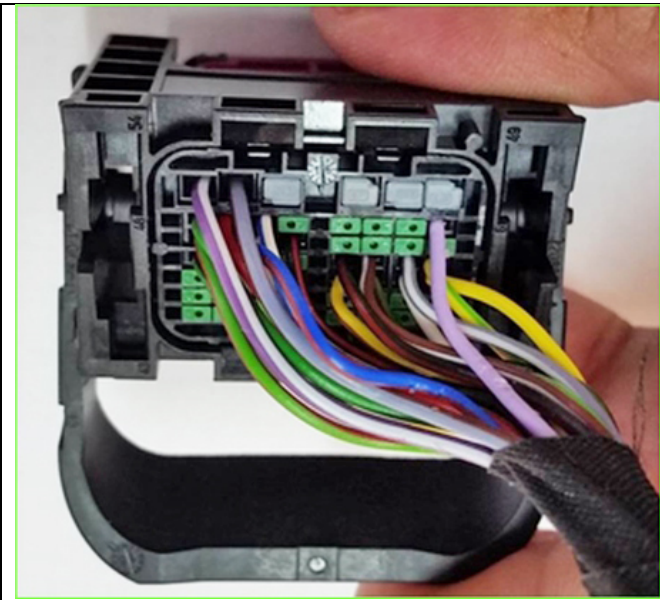
2d. All slots in the connector must be occupied with a wire or sealing plug.

2e. Install suitable sealing plugs (Repair kit P/N 61 12 8 794 765) into all of the open chambers.

Fit green sealing plugs into the open chambers in positions 1 thru 48 on connector A368*1B

Fit "natural colored" sealing plugs into the open chambers in positions 49 thru 54

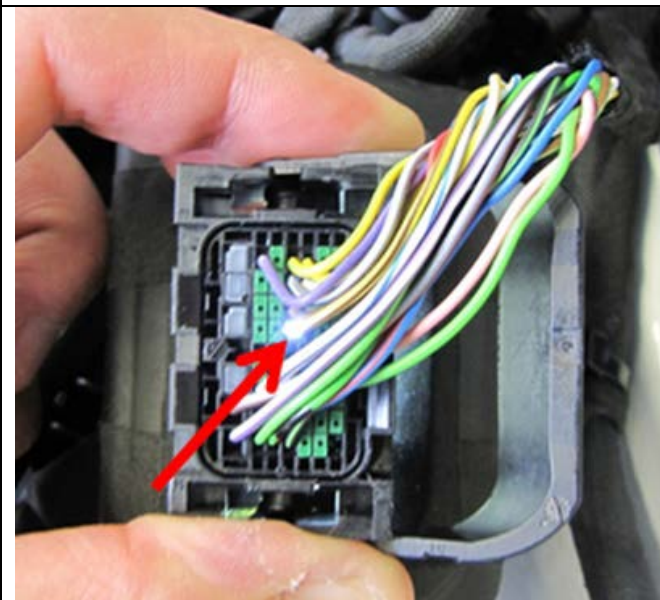
Shine a flashlight from the front of the connector to locate any open chambers (arrow).

Install any remaining sealing plugs.
