SI M41 02 17
Body

SERVICE ACTION: LEFT SIDE SILL INSPECTION-REPAIR

F57 (Cooper, Cooper S, JCW Convertible)			
---	--	--	--

DOOR SILL CRACK REPAIR

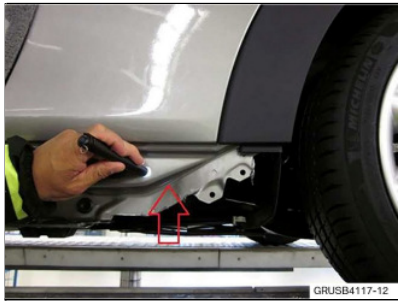
A possible crack may cause water leakage into internal vehicle structures with subsequent corrosion.

A production issue during panel formation, has led to the possibility of cracks being created in the radius of the outer left side frame (below the side sill trim panel).

<ol style="list-style-type: none"> 1. Remove the left side sill trim panel as detailed in REP 51 71 447 "Removing and installing/replacing the side sill trim panel on the left or right side."
	<ol style="list-style-type: none"> 2. Check for a crack in the side sill by shining a light into the opening for the clip as shown. <p>Does light shine through the crack near the inner radius of the side frame?</p>

YES- follow the attached repair procedure -
M410217_Attachment-Door Sill Crack Repair

NO – reassemble the vehicle and release.
