Preliminary Information

PIT5119E Intermittent Remote Keyless Entry Inoperative

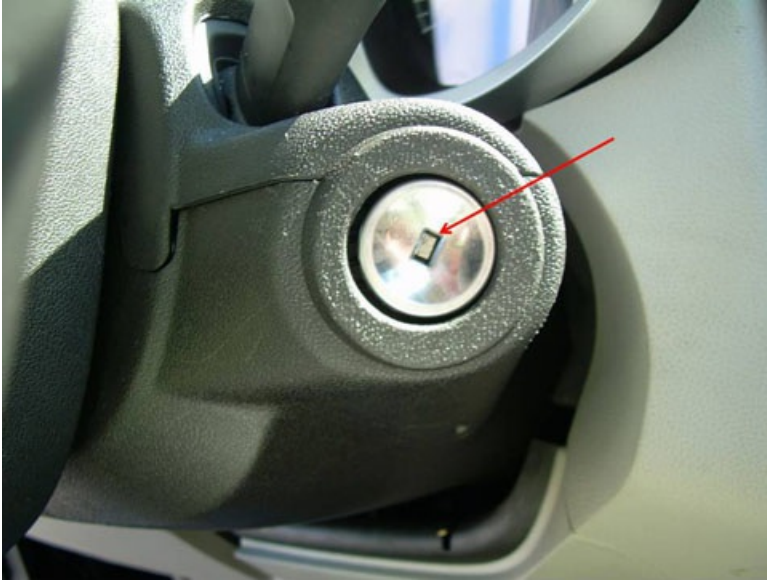
Ignition key door in correct position

Use a Lubriplate type of lubrication spray and lubricate the ignition key cylinder door. Insert the tip of the key in and out to verify the door of the cylinder is not sticking.
