Service Bulletin

Subject: Vibration Analysis Diagnostic Aids

Brand:	Model:	Model Year:		VIN:		Engine:	Transmission:
		from	to	from	to		
Cadillac	Escalade Models	2015	2017				
Chevrolet	Suburban						
	Tahoe						
GMC	Yukon Models

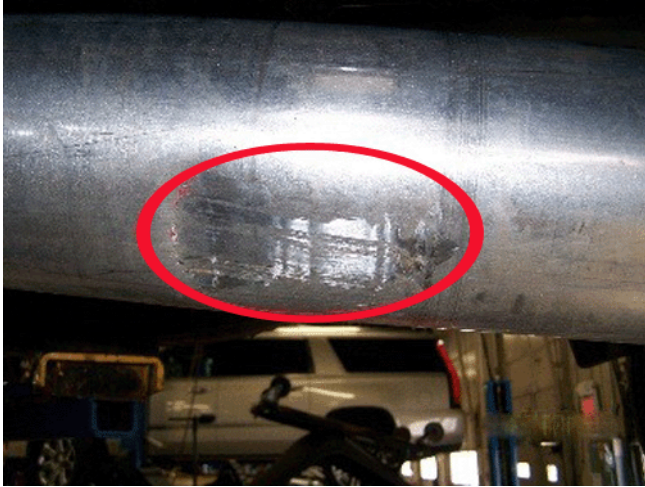
1. Inspect the propeller shaft for dents, damage, and missing weights. There have been many cases of dented propeller shafts. Damaged prop shafts must be replaced.
