Service Bulletin

Subject: Information on Vibration Analysis and Diagnostic

Models: 2014 Chevrolet Silverado 1500
2015-2017 Chevrolet Silverado
2014 GMC Sierra 1500
2015-2017 GMC Sierra

This PI has been revised to add the 2017 Model Year and update the applicable information below including adding the Replace Steering Bushings section. Please discard PI1354D.

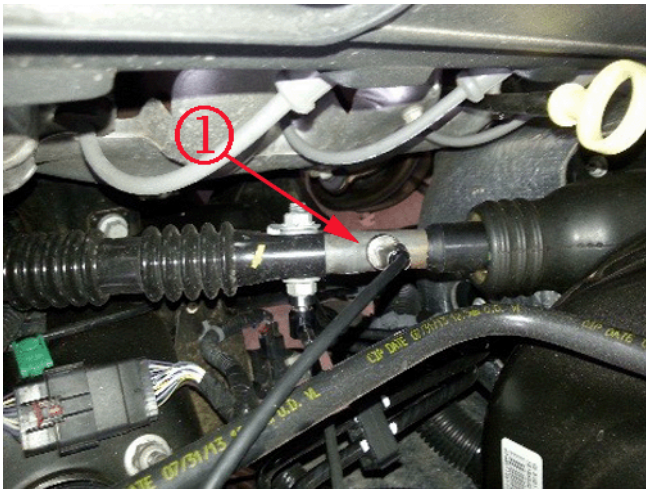
4. This step should be only be used if the vibration can be felt while running the vehicle on the rack. Mount the sensor on the steering shaft(1), under the hood as illustrated above.

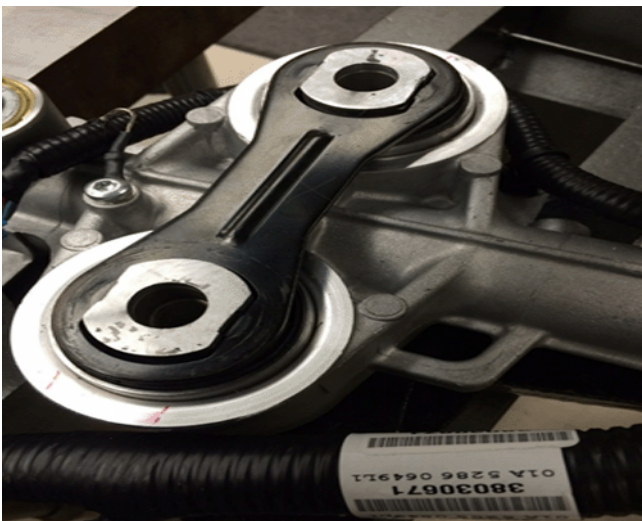
A revised steering bushing (2) has been released to address customer vibration concerns. After various testing and measurement of the T1 vibration, a vibration path from the tie rods =>steering rack=>steering bushings=>frame=>Body Mount=>Cabin Floor=>Seat has been identified. To help isolate the steering rack (1), a revised hydraulic bushing has been released and tuned to the T1 frequency. The new steering bushing dampens minor T1 vibrations. This is the reason that the causal part (normally the Tire/Wheel Assembly) must be corrected first. If the T1 vibration is over 20-25m/g's, the bushings will have little to no effect.

For vehicles with T1 vibrations under 20-25m/g's, replace steering bushing per parts catalogue. Utilize SI procedure "Steering Gear Mount Bushing Replacement" for replacement of the steering bushings.

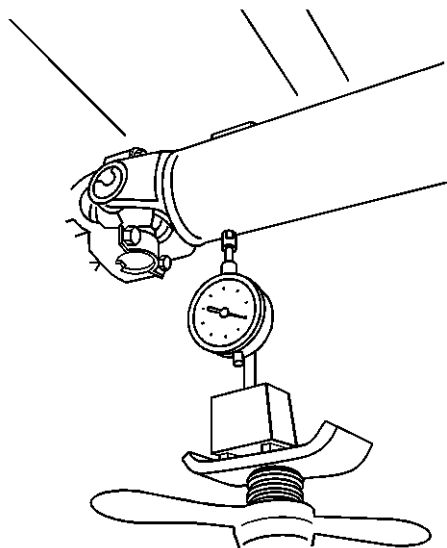
- This measurement procedure is intended to measure propeller shaft runout for prop shaft systems with 2 or 3 U-joints only. This is not for prop systems with only 1 U-joint, or with only constant velocity (CV) joints, and/or coupler assemblies.
 - When measuring runout of propeller shafts, do not include fluctuations on the dial indicator due to welds or surface irregularities.
1. Raise and support the vehicle with the wheels free to rotate. Refer to the Lifting and Jacking the Vehicle in SI.
 2. Place the transmission in NEUTRAL.
 3. Clean the circumference of the propeller shaft of any debris and/or undercoating along the rear of the shaft, where contact of the dial indicator will make to the propeller shaft.
 4. Inspect the propeller shaft for dents, damage, and/or missing weights. Any propeller shaft this is dented or damaged requires replacement.

5. Mount the GE-7872 Magnetic Base Dial Indicator Set, or equivalent, or the GE-8001 Dial Indicator Set, or equivalent, to the vehicle underbody or to a service stand positioned just clear of the U-joint yoke weld on the prop shaft.

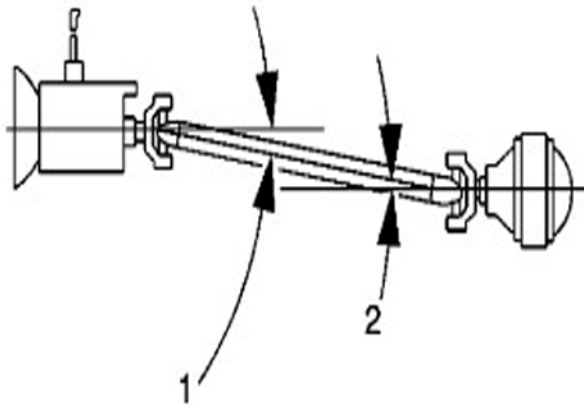
Measurement	Notes:
Yoke to Shaft		The first (forward most) U-joint action on a two piece driveshaft system is not canceled out by another U-joint. Because of this, the first U-joint working angle should be between 0.5 and 0.75 degrees.
Front Shaft to Center Support Bearing (if equip)		U-joint pairs cancel each other. Neither U-joint working angle should exceed 4 degrees, nor the allowable range of difference between cancelling U-joint working angles is 0.00 to 1.0 degrees.
Shaft to Diff Yoke

Propeller systems containing only 1 U-joint: The U-joint working angle should be between 1/2 and 3/4 degrees.

Allowable range of difference between cancelling U-joint working angles: 0.25 to 1.0 degrees.

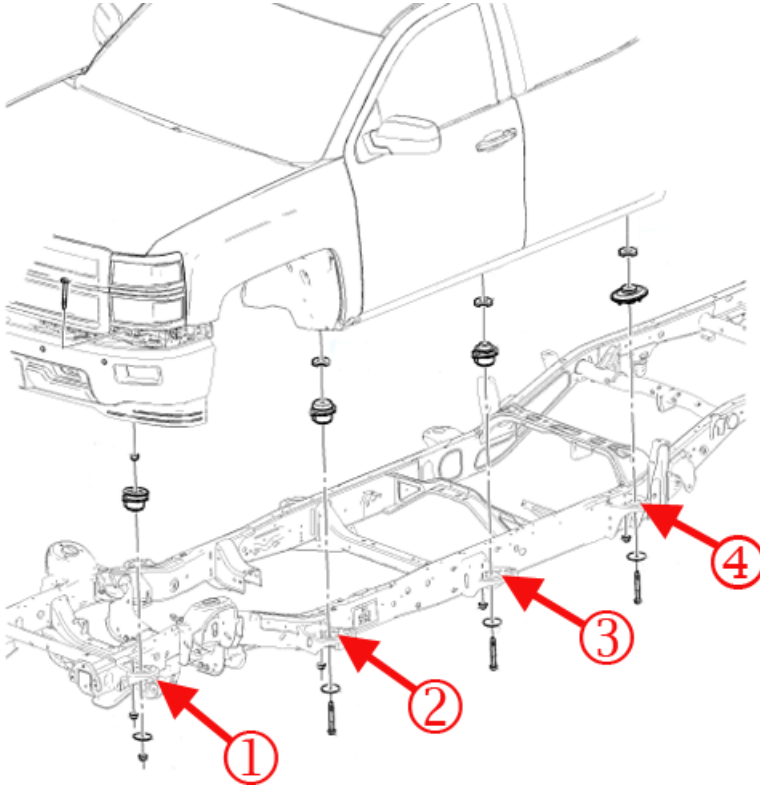
The cab / body mount position location

The numbers in the picture below indicate the specific mount position. The mounts on the passenger side of the vehicle are identified the same way. This will assist the technician to identify the correct location of each mount so they can be torque to the proper specification.

- 1 = body mount cushion front
- 2 = body mount cushion position number 1
- 3 = body mount cushion position number 2
- 4 = body mount cushion position number 3

Visually verify that the cab to box alignment is correct before re-torquing all mounts to specification found in Service Information, body repair, frame and under body section.

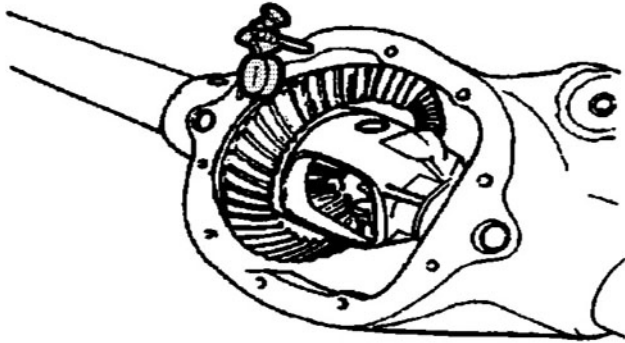
3. Pitchline runout – Pitchline runout will normally show as a 1st order tire vibration on the PicoScope. If after correcting tire(s) with excessive Road Force, a vibration exists, remove differential cover and check ring gear backlash. Every tooth should be checked for excessive backlash. If there is more than 0.0762 mm (0.003 in) of variation, the ring gear and/or differential should be replaced to correct the condition (SI Document ID# 3269088, 3620298) (PIP4148).

1. Measure the rotating torque of the drive pinion and differential assembly. Refer to the Differential Drive Pinion Gear Bearing Replacement in SI.

2. Install the J-25025 pins and the J-8001 indicator to the axle housing.
