# Service Bulletin

Bulletin No.: 15-NA-051

**Subject:** Vehicle Stalls While Driving, No Start/Stalling

Brand:	Model:	Model Year:		VIN:		Engine:	Transmission:
		from	to	from	to		
Buick	Lucerne	2008	2011			All	All
Cadillac	DTS	2009	2011

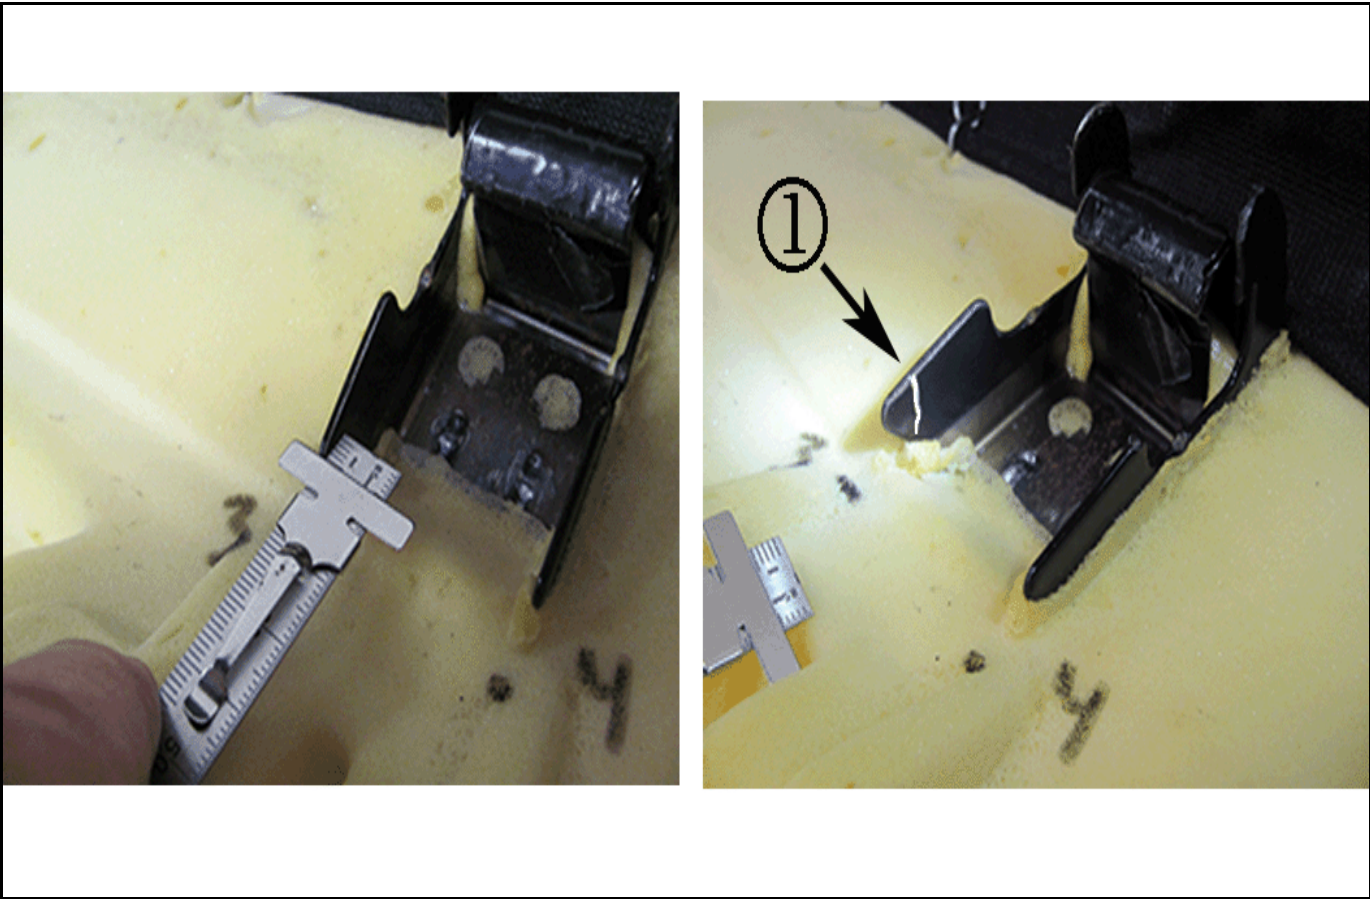
## Rear Seat Bracket Repair for Lucerne

- Contact marks from the seat brackets. (Lucerne Only)

1. With the rear seat cushion on a bench, measure 5 mm (0.197 in) from each edge of the right side seat mount bracket and mark with a paint marker as shown (1).
