# Service Bulletin

Bulletin No.: 17-NA-259

**Subject:** Body Creak Noise from Rear Seat Area

Brand:	Model:	Model Year:		VIN:		Engine:	Transmission:
		from	to	from	to		
Chevrolet	Camaro	2016	2018			All	All

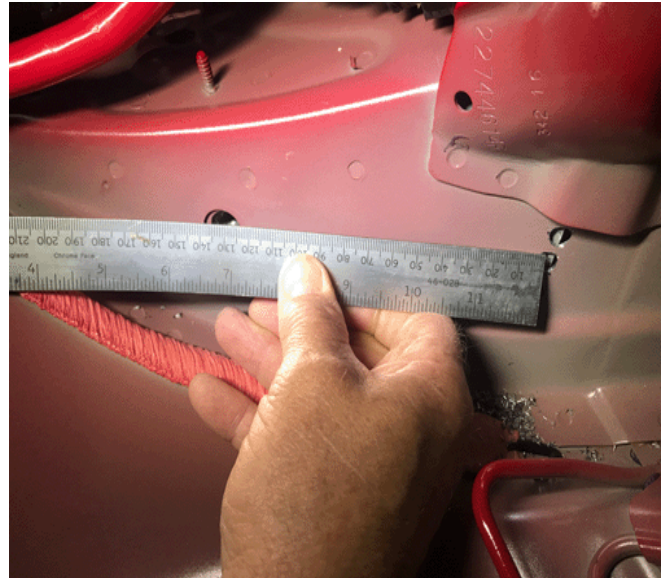
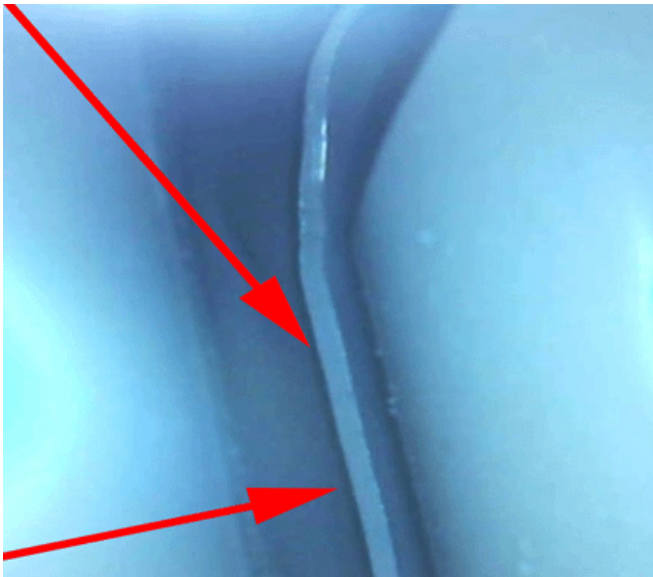
5. With the borescope inspect the two panels for either missing bond or imperfections (inadequate bond wet-out).
  - If imperfections are not visible, continue to Step 12.
