# Service Bulletin

Bulletin No.: 17-NA-258

**Subject:** Excessive Wind Noise from Front Side Door Glass Area

Brand:	Model:	Model Year:		VIN:		Engine:	Transmission:
		from	to	from	to		
Chevrolet GMC	Silverado 1500 Sierra 1500	2014	2014			All	All
Chevrolet GMC	Silverado Sierra	2015	2018

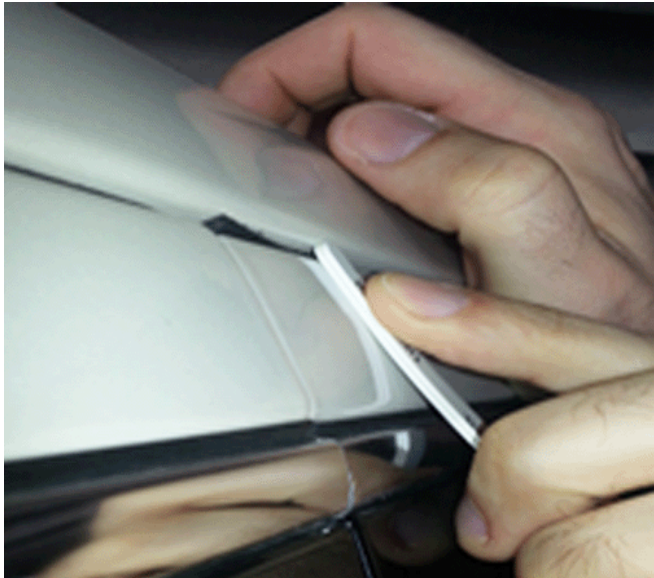
**Note:** These vehicle models use an inlay door construction, with the door fitting sub-flush to the body header by 1-2 mm (0.040–0.080 in).

1. At the two locations (1) shown in the illustration above, inspect the front door fit as to meeting the suggested 1-2 mm (0.40–0.80 in) sub-flush dimension.
  - If the door fit meets the sub-flush specification, no door adjustment is necessary and you can jump ahead to step #4.
  - If the door fit DOES NOT meet the sub-flush specification, continue to step #2 to start the door adjustment.

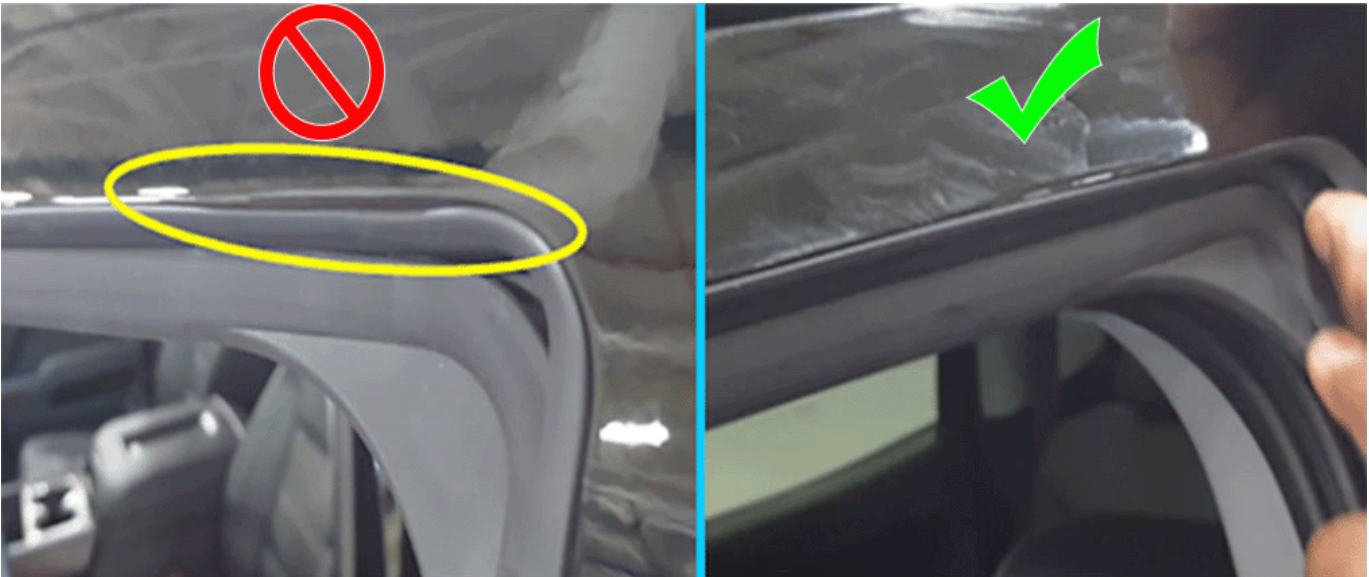
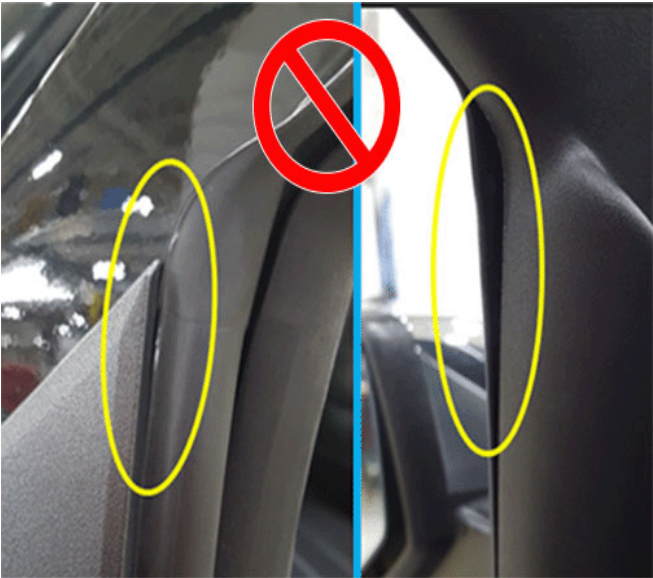
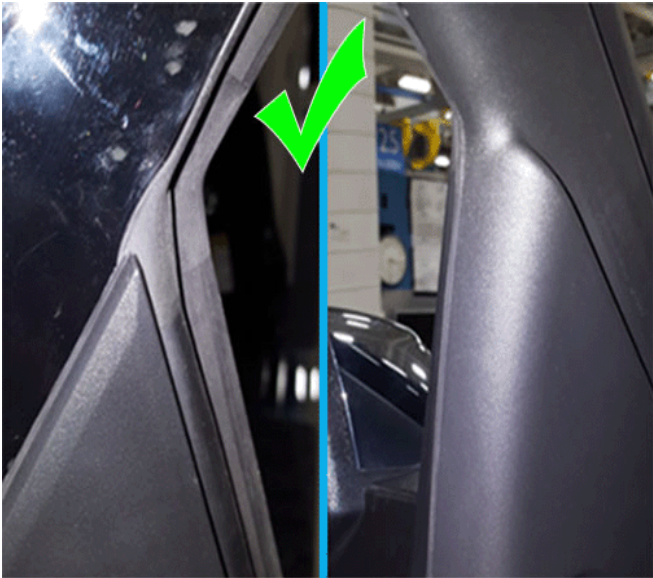
**Note: The graphics below are “before and after” examples which help show the proper positioning of the front door window weatherstrip.**

**Important:** The last example above shows the front, upper corner of the weatherstrip installed too high and well out of position. The feature line (shown circled) should be located down at the center-line of the metal notch.
