Service Bulletin

Bulletin No.: 16-NA-339

Subject: Vibration Analysis Diagnostic Aids

Brand:	Model:	Model Year:		VIN:		Engine:	Transmission:
		from	to	from	to		
Cadillac	Escalade Models	2015	2018				
Chevrolet	Suburban						
	Tahoe						
GMC	Yukon Models

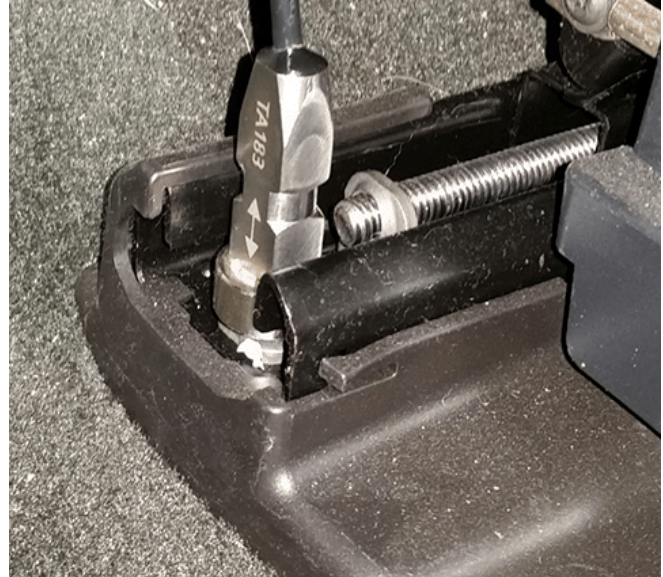
4532459

(TA183 single axis pico sensor shown / TA143 is tri-axis sensor)

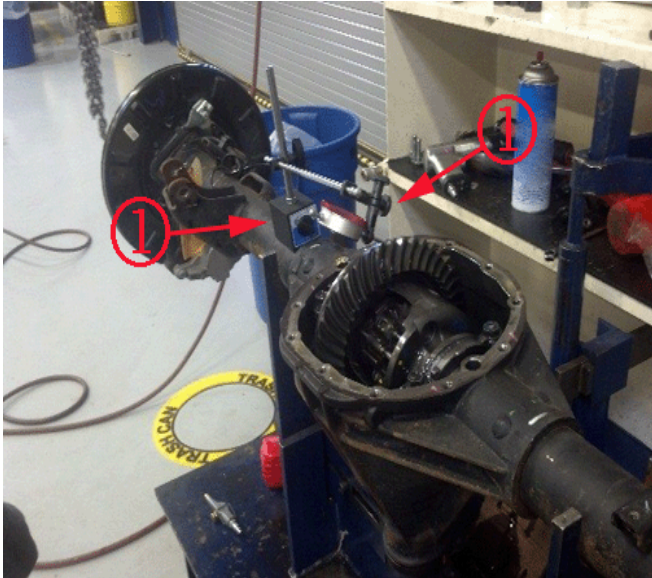
4002895

If drive axle repair is necessary, we have heard some reports that during repair, tooling chatter marks may be observed in the pinion race counter bores. This issue lends to the idea that the races may not be fully seated until some vehicle use is introduced into the axle. This issue would most often result in a noise concern, though severe loss of preload might produce a vibration. The races should be able to be fully seated during repair.

Note: The illustration above is for reference only. The axle does NOT need to be removed from the vehicle.
