# Service Bulletin

**Subject:** Convertible Top Creak or Snap Noise While Driving

Brand:	Model:	Model Year:		VIN:		Engine:	Transmission:
		from	to	from	to		
Chevrolet	Corvette Convertible	2014	2016			All	All

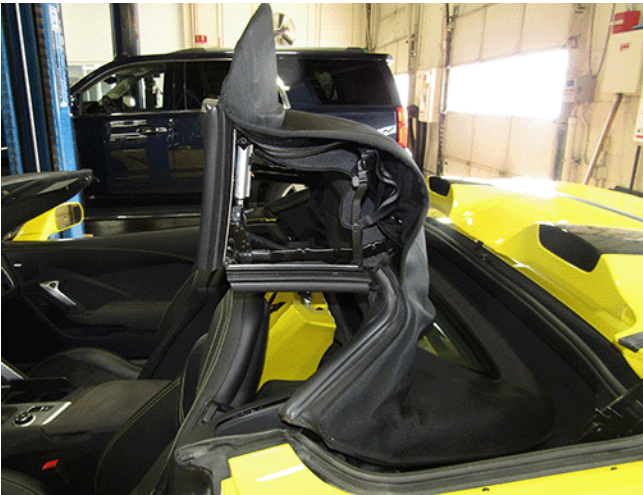
**Warning: Due to bleed off of the hydraulic pressure, the folding top will have to be supported or held in mid-position by an assistant. Manual operation of the top cannot be attempted for at least 5 minutes from the last time of activation.**

1. Power the folding top into the mid-open position.
