SERVICE ACTION: SERVICE ACTION: N63T ENGINE - CHECK AND REPLACE THE CRANKCASE VENTILATION HOSES

This Service Information bulletin replaces SI B11 12 16 **dated July 2016**

F01 (7 Series Sedan)	F02 (7 Series Sedan LWB)	F06 (6 Series Gran Coupe)	F07 (5 Series Gran Turismo)
F10 (5 Series Sedan)	F12 (6 Series Convertible)	F13 (6 Series Coupe)	F01 B7 (ALPINA B7)
F02 B7 (ALPINA B7 LWB)	F06 (ALPINA B6)

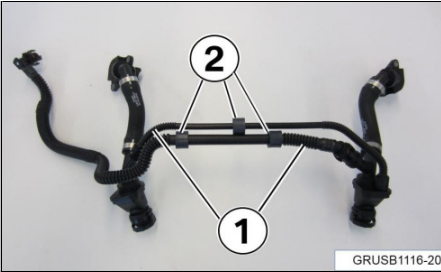
<p>GRUSB1116-20</p>	<p>engine. Do not remove the hoses to make the inspection.</p>
<p>Or</p>

<p>GRUSB1116-19</p>	<p>2. Inspect the crankcase ventilation hoses. If the hoses are constructed of the FPM material (1) then take no further action and reassemble the vehicle.</p> <p>The FPM material will appear to be a smooth rubber hose material.</p> <p>For clarity the hoses are pictured removed from the engine. Do not remove the hoses to make the inspection.</p>
<p>Or</p>	
<p>If the crankcase ventilation hoses are constructed of a plastic coggurated material (1) then the pipes must have all three of the self-locking spacers (2). If these hoses have all three self-locking spacers (2) then take no further action and reassemble the vehicle. For clarity the hoses are pictured removed from the</p>
