## SERVICE ACTION: CHECK PUMP FOR BACKREST WIDTH ADJUSTMENT

F80 (M3 Sedan)	F82 (M4 Coupe)
----------------	----------------

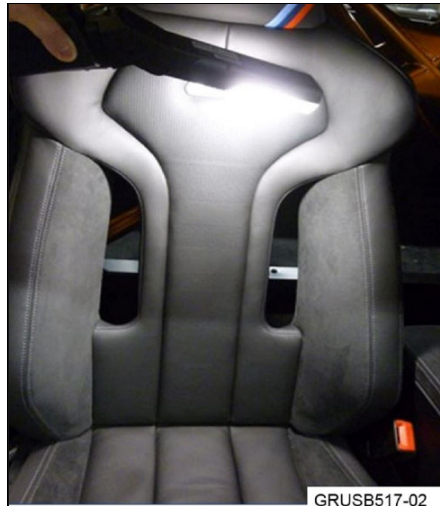
Competition seat with option code 7MA

Note: Competition package vehicles have only backrest width adjustment - no lumbar support adjustment.
