Preliminary Information

PIP5487A 2017 6.6L L5P Duramax Coolant Leaks

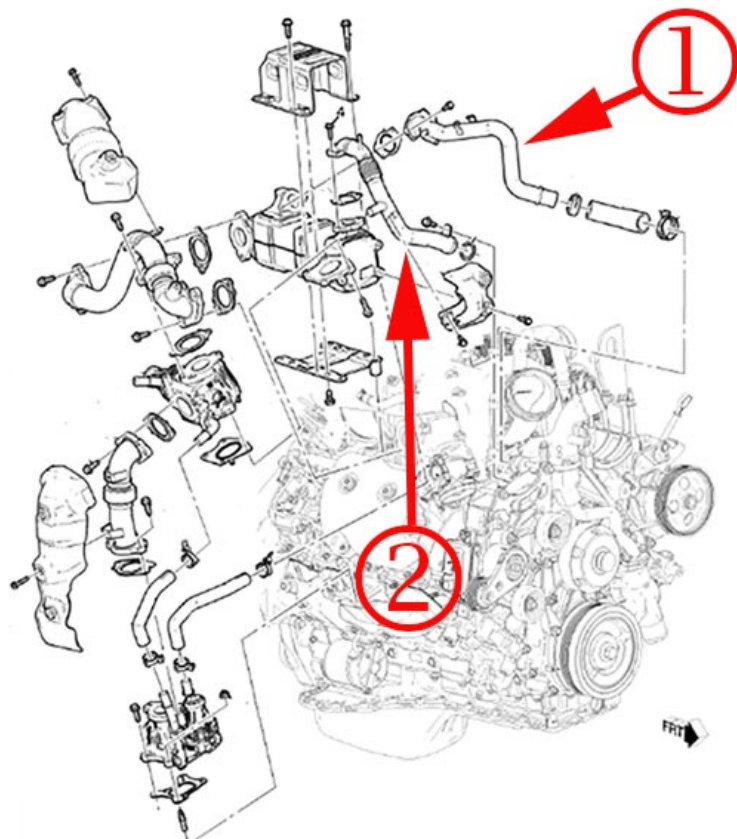
If the diagnosis has lead to external coolant leaks or a coolant loss concern check for leaks in the following areas:

Welded flange leaking on the Exhaust Gas Recirculation (EGR) coolant return pipe. Refer to call out #1 in the above picture.

Welded flange leaking on the Exhaust Gas Recirculation (EGR) coolant feed pipe. Refer to call out #2 in the above picture.
