Emissions Recall – USA ONLY Code: 24CX

Subject	Inlet Air Box Housing Snow Flap Replacement & Oxygen Sensor Inspection/Replacement					
Release Date	June 01, 2017					
Affected Vehicles	U.S.A.: 2012-2014 MY Volkswagen Passat 2.0L TDI (GEN 2)					
	Check Campaigns/Actions screen in Elsa on the day of repair to verify that a VIN qualifies for repair under this action. Elsa is the <u>only</u> valid campaign inquiry & verification source.					
	 ✓ Campaign status must show "open." ✓ If Elsa shows other open action(s), inform your customer so that the work can also be completed the same time the vehicle is in the workshop for this campaign. 					
Problem Description	The snow flap in the inlet air box housing may remain partially to fully open. Should this occur, excess warm air could enter the air intake through the snow flap inlet.					
	The oxygen sensor will be checked during this service and, if measured degradation tolerances are met, the sensor will be replaced.

Subject: Emissions Recall 24CX - Inlet Air Box Housing Snow Flap Replacement & Oxygen Sensor Inspection/Replacement 2012-2014 Model Year Volkswagen Passat 2.0L TDI (GEN 2)

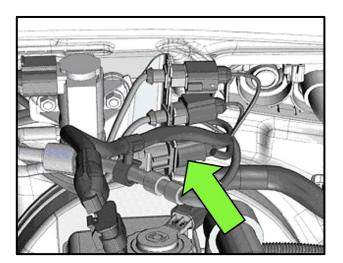
- If the message noted to the left was displayed • during campaign 23U4 during the "Adapt software, diesel, exhaust EA189 action 23XX", the test plan has determined that the heated oxygen sensor -G39- must be replaced.
 - If the message noted to the left was 0 displayed during campaign 23U4 and the heated O2 sensor -G39- requires replacement per the test plan results, Proceed to the next step and replace the heated O2 sensor.
 - If you **DID NOT** receive the message 0 noted to the left during campaign 23U4, the heated O2 sensor does not require replacement per the test plan results. Proceed to Section D and replace the snow flap.
- If this campaign action is being performed as a stand-alone operation not in conjunction with the 23U4 Campaign, Proceed to Section C to manually check, and if necessary, replace the heated O2 sensor -G39-.

Replace heated O2 sensor -G39-, if required:

- Remove the engine cover.
- Disconnect electrical connector <arrow> for the heated oxygen sensor -G39-.
- Free up the wiring harness. •
- Loosen and remove the original heated oxygen sensor -G39- <arrow> from diesel particulate filter using the ring wrench 7-piece set -3337-.
