Technical Bulletin

24 17 09 September 25, 2017 2045138 Supersedes Technical Bulletin 24-17-08 (V241708) dated August 7, 2017 to update Top Tier Fuel Brochure part number and update literature ordering site address.

MIL ON DTCs P2004, P2014 and or P2015 Stored in ECM Fault Memory

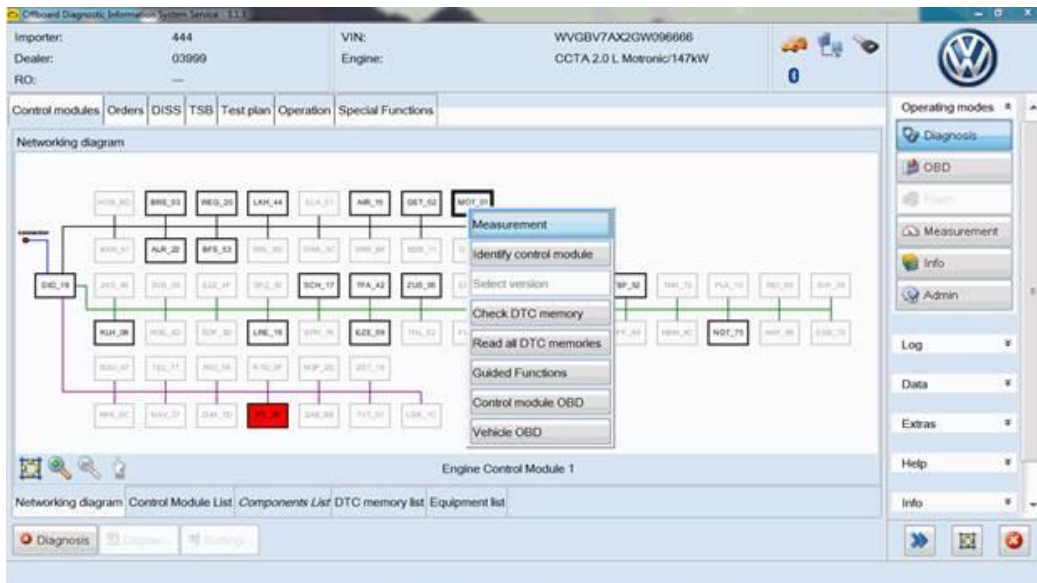
Figure 4

- Check the diagnostic limits of the flap with the ODIS tester.
- Under Motor, select Guided Functions (Figure 4).

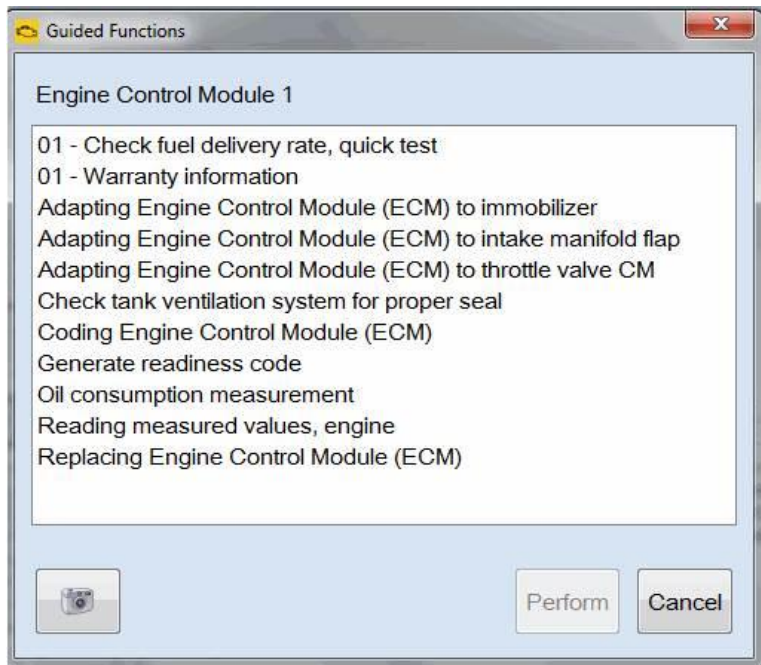
Figure 5

- Select Adapting Engine Control Module (ECM) to intake manifold flap (Figure 5).

If the adaptation is not successful, the flap stop is worn internally, the intake manifold also has to be replaced. See Repair Group 24 Multiport Fuel Injection in Elsa.
