# Technical Bulletin

**24 17 04** June 29, 2017 **2045138** Supersedes Technical Bulletin 24-17-03 (V241703) dated March 6, 2017 for information regarding a new style solenoid valve for Intake Manifold Flap -**N316**.

**MIL ON DTCs P2004, P2014 and or P2015 Stored in ECM Fault Memory**

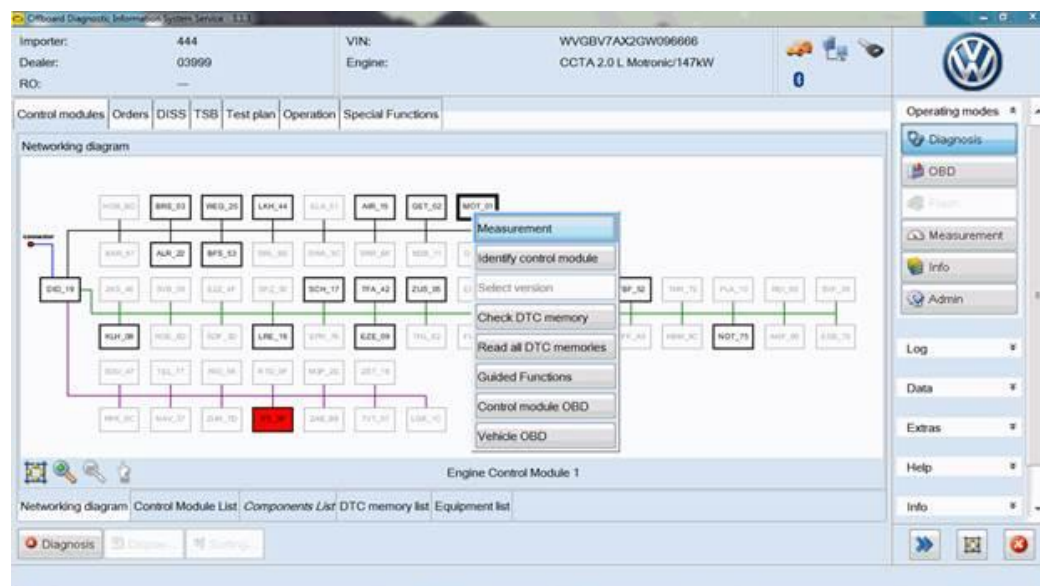
Figure 4

- Check the diagnostic limits of the flap with the ODIS tester.
- Under Motor, select Guided Functions (Figure 4).

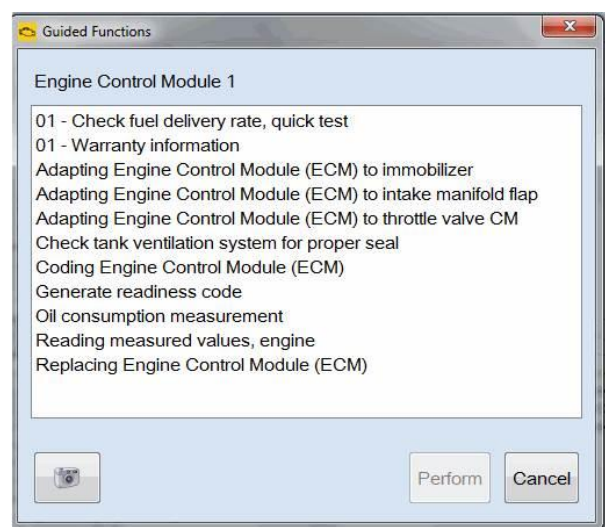
Figure 5

- Select Adapting Engine Control Module (ECM) to intake manifold flap (Figure 5).

If the adaptation is not successful, the flap stop is worn internally, the intake manifold also has to be replaced. See Repair Group 24 Multiport Fuel Injection in Elsa.
