## **Service Bulletin**

Bulletin No.: 17-NA-294

Subject: Radio Control Display is Scrambled, Split, Pixilated, or Displays Vertical Lines

Brand:	Model:	Model Year:		VIN:		Engine:	Transmission:
Біапи.	wiodei.	from	to	from	to		
Chevrolet	Traverse	2018	2018			All	All

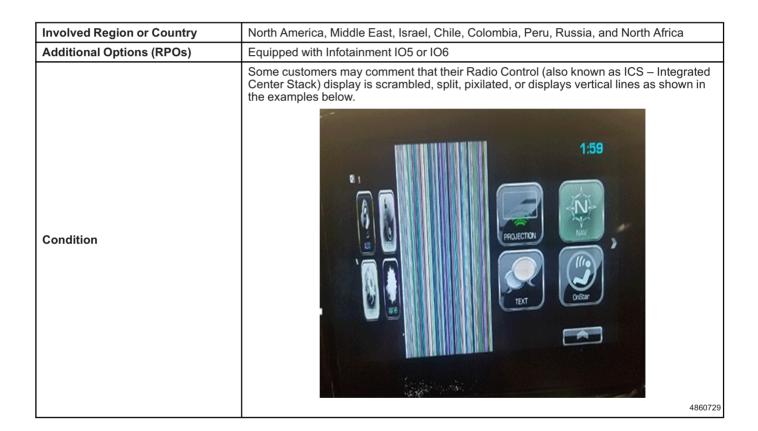
Upon inspection, the technician will not find any related codes stored and normal audio from the speakers will be experienced as well.

Cause	This may be the result of the internal memory being overwritten during certain module communication sequences.		
Γ	Correction	If this concern is encountered, replace the radio control (ICS) assembly.

If you encounter a vehicle with the above concern, replace the radio control (ICS) assembly. Refer to Radio Control Assembly Replacement with IO5, IO6 in Service Information for detailed instructions.
