Technical Journal

Seats second row, outer seats, noise

REF NO: TJ 30599.3.2			ARKET: s and Canada
3 US 7	PARTNER: '510 Volvo Car USA	ISSUE DATE: 2017-01-17	STATUS DATE: 2017-01-24
FUNC GROUP: 8530	Rear seat, passenger seat.		1 of 12

Title	Rear seat, second row	Page	1 (10)
Action	Product fix	Operation number:	98641-2

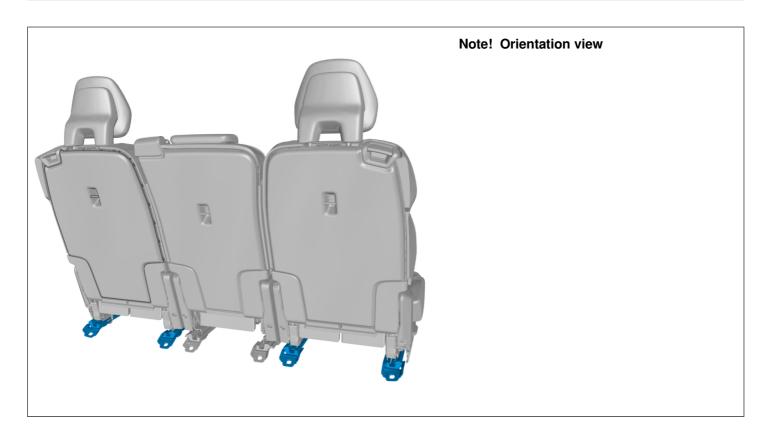
Vehicles manfactured before chassis number 25976

Note: Observe that page 10 and onwards in the method, only applies for cars with chassis number. up to 25976. On later cars, the sliding rails has been modified.
