To: All U.S. and Canadian Volvo Retailers  
Subject: Service Action S89833

Volvo Car USA LLC and Volvo Car of Canada Ltd (Volvo) on behalf of Volvo Car Corporation, has decided to launch Service Campaign S89833 on certain model year 2017 S90 vehicles.

**SERVICE ACTION S89833 Replace Headliner Clip**

<b>Title</b>	Replace headliner clip	<b>Page</b>	1 ( 3 )
<b>Action</b>	Service action	<b>Operation number:</b>	97186-2

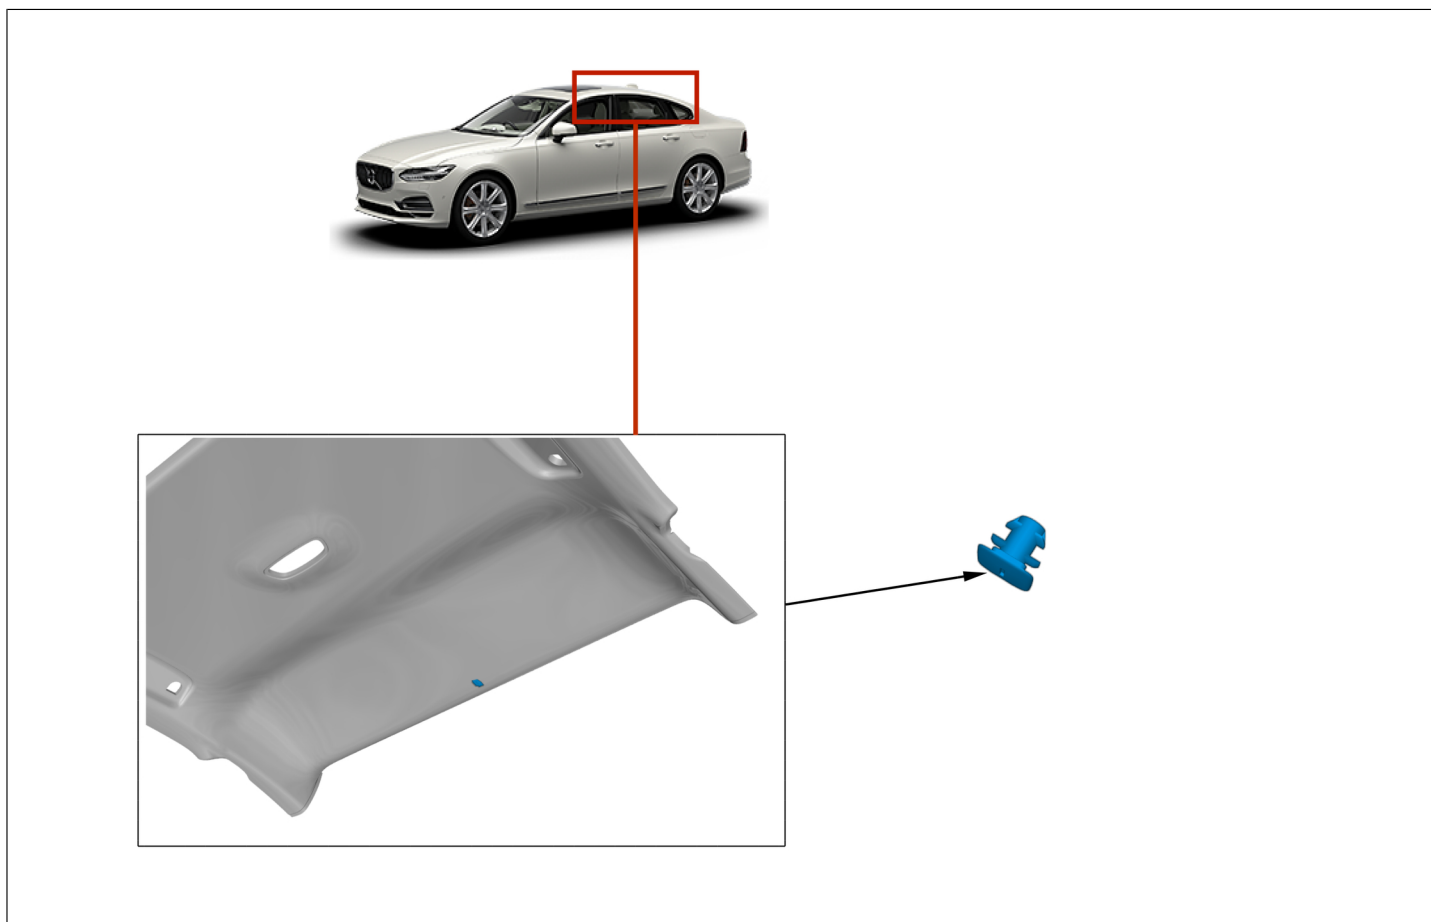
## Removal

Volvo has identified that the headliner may become loose at the rear window.

The corrective action is to replace the rear headliner clip.
